# 66-INCH, I-270 PCCP PIPELINE REHABILITATION

## Gaithersburg, Maryland

### OVERVIEW

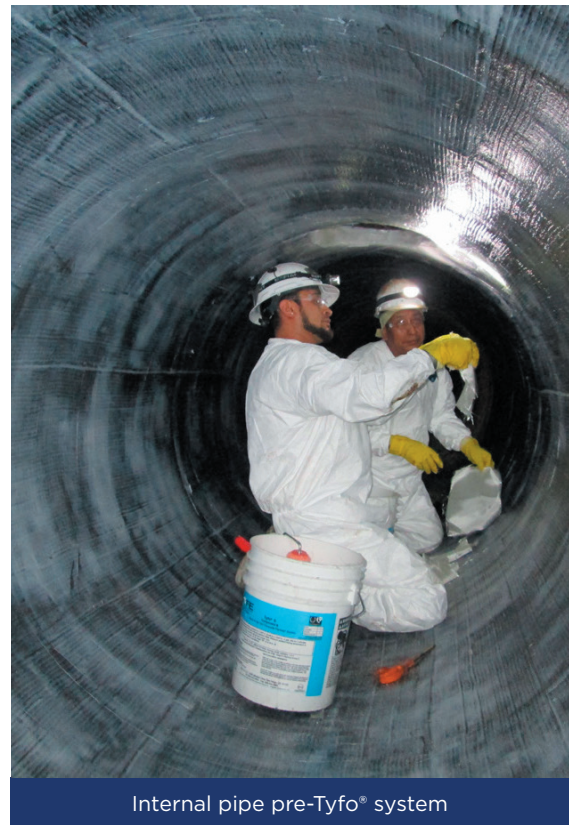
In March 2013, Washington Suburban Sanitary Commission (WSSC) contracted a third party inspection company to perform an electromagnetic survey to assess the condition of their 2,990 feet of 66-inch PCCP pipeline. It was found that numerous sections of the inspected 66-inch line had broken pre-stressed wires and were structurally unsound. Thirteen of these pipe sections were in the vicinity of Interstate 270. WSSC conducted feasibility studies and determined the traditional remove-and-replace option for these distressed pipe sections would not be practical and contacted Fyfe to consider a carbon fiber reinforced polymer (CFRP) retrofit of the damaged segments of pipe.

Internal pipe pre-Tyfo® system

Fibrwrap Construction installed the Tyfo® SCH-41 2X system (unidirectional carbon fiber) both in the circumferential and longitudinal directions. The materials were designed as a standalone repair to withstand operating and transient pressures as well as gravity loads.

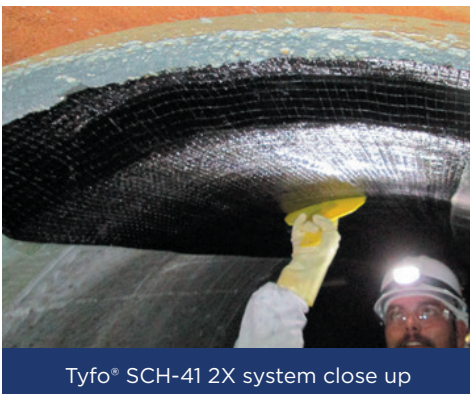
Tyfo® SCH-41 2X system close up

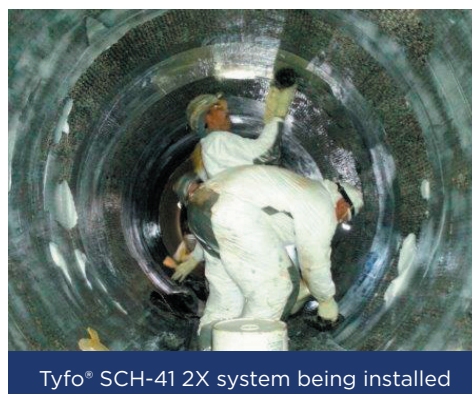
Tyfo® SCH-41 2X system being installed

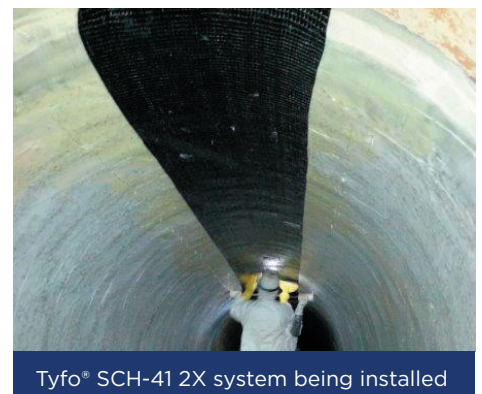
Tyfo® SCH-41 2X system being installed
