**Location:** Rock Springs, WY

**Application:** Arched Storm Culvert

### CASE STUDY:

## Arched Storm Culvert Rock Springs, WY

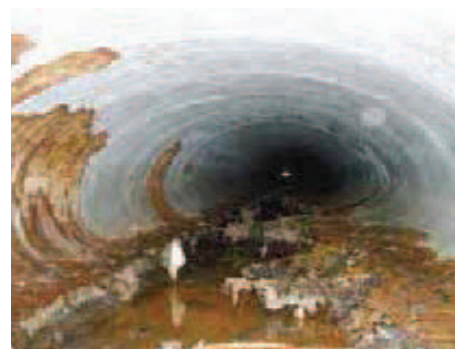
The invert of the pipe, which was covered with dirt and trash, was mostly corroded away. In fact, approximately 18 inches of the underlying soil had been eroded along the full length of the culvert. In addition to the invert, there were joint separations of more than six inches in many of the joints. The crown had also caved in over a 10-foot section of the structure running directly under the road.

Damaged corrugated metal culvert.

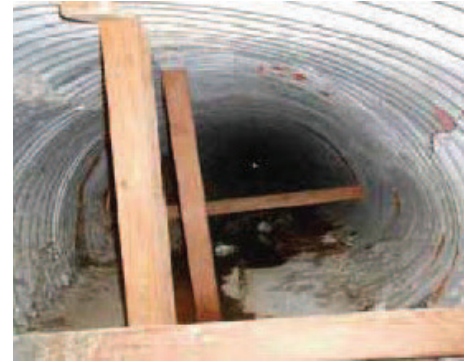
High-risk areas braced with timber.

To begin the repair, the culvert was first excavated and cleaned. Next, the pipe areas in danger of collapse were braced with timber, ensuring the safety of the work crew and the general public.

The major flaws in the pipe were then addressed. The timber bracing was used to return the crown to its original shape. Standard portland cement fill was laid in the invert of the culvert to replace the missing soil and the joints were repaired.

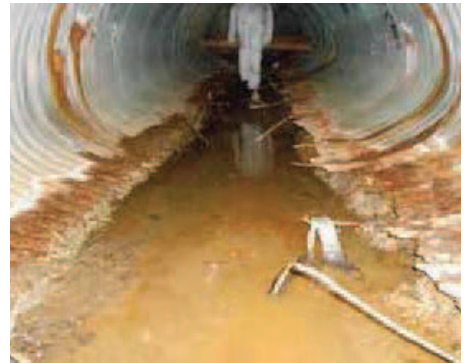
The repair began with excavating and cleaning.

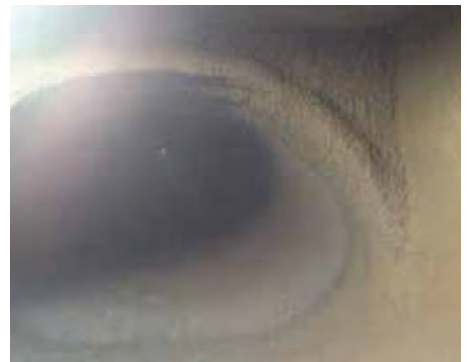
GeoSpray liner applied to the culvert.

Once the basic shape of the pipe was returned to normal, the GeoSpray liner was applied to the culvert to return the structural integrity of the system and create a like-new condition. The liner was applied using standard spray nozzle techniques to a final thickness of one and a half inches. The inlet and outlet of the culvert were also treated with GeoSpray liner to create a monolithic structure.
