# Clock Spring Repairs 24-inch Crude Oil Pipeline

Onshore

### Pipe Details

- 610 mm (24-inch) carbon steel X52 crude oil pipeline was dented with a crack in the seam weld

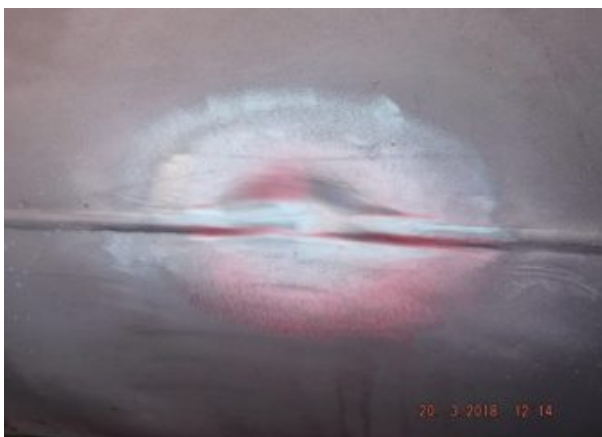
An onshore 610-mm (24-inch) carbon steel X52 crude oil pipeline sustained a dent and a crack in a seam weld that was in need of repair. The owner needed an efficient, affordable, and long-lasting solution.

*A carbon steel crude oil pipeline had sustained a dent and a related crack in a seam weld.*

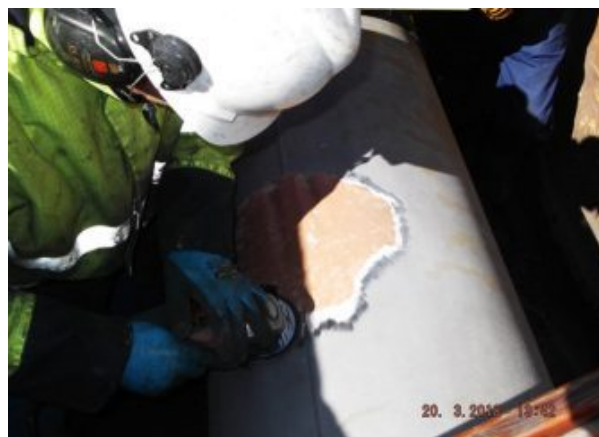
*Skilled technicians remove the crack in the seam weld with a grinder.*

In the interest of safety, the pipeline operator took the line out of service (but did not evacuate it) while skilled technicians removed the crack in the seam weld with a grinder. When the installers had ground the pipe sufficiently to remove the crack and filled the dent using the filler kits, they were ready to repair the area with the Clock Spring composite sleeves, installing them using the hand spool method.

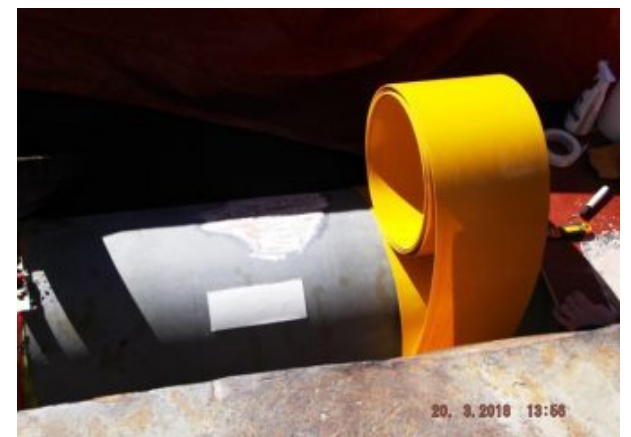
*The Clock Spring composite sleeves are installed using the hand spool method.*

The team of 2 technicians fully installed the repair sleeves in about 4 hours, executing the installation without introducing safety risks and delivering a complete repair in less than 25% of the time and at approximately 35% of the cost of the carbon fiber composite solution. The rapidly executed installation allowed the owner to minimize downtime and delivered a repair validated for 50 years of service.

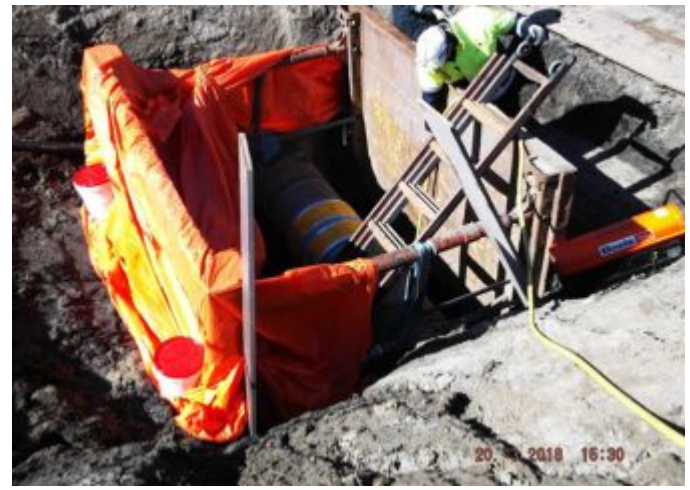
*Clock Spring Repairs Crude Oil Pipeline*
