# Contour Repairs Corrosion Under Insulation at a Gas Station

Australia

### Pipe Details

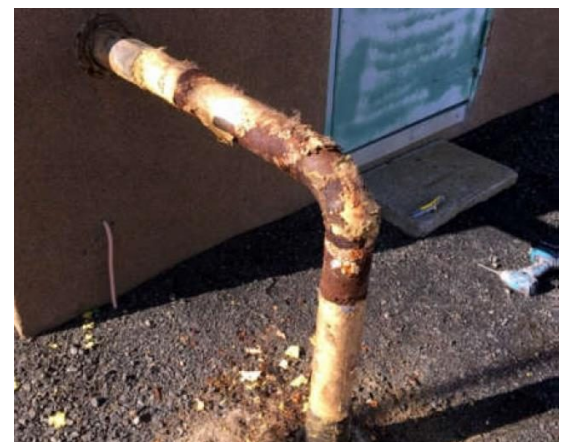
Nondestructive testing on a line at a natural gas distribution station uncovered corrosion under insulation on a 76-mm (3-inch) API 5L Grade B steel pipeline designed for 70 bar (1,015 psi) pressure and an operating temperature of 60° C (140° F). The original wall thickness of 5.5 mm (2.2 inch) had eroded, leaving only 2 mm (0.08 inch) remaining.

*Defect after removal of insulation*

Because it was important for the section of pipe to remain operational while the corrosion was addressed, the owner selected a Clock Spring Contour repair.

Using the specific characteristics of the pipe, Clock Spring designed a repair to ISO 24817 2015 guidelines, which provide requirements and recommendations for qualifying, designing, installing, testing and inspecting the external application of composite repair systems to corroded or damaged pipework, pipelines, tanks, and vessels used in the petroleum and natural gas industries.

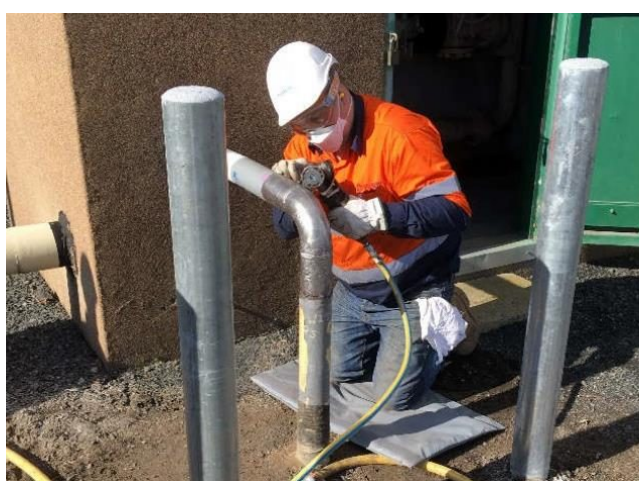
*Surface preparation by bristle blaster*

Local trained and certified technicians cleaned the pipeline with a bristle blaster to a finish equivalent to SA2.5 and then washed it with solvent and installed four layers of Clock Spring Contour. Once the installation was complete, the pipe was re-insulated.

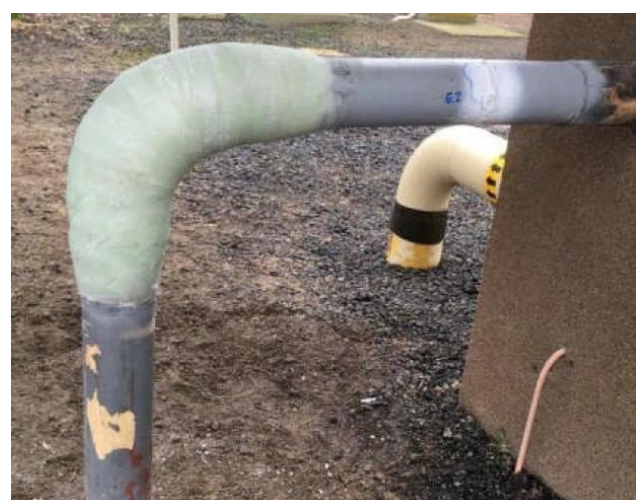
*Completed repair*

The repair was completed with the pipe online and without any disruption to the local gas supply.
