# Contour Repairs Leak Under Insulation in Ammonia Plant

Australia

### Pipe Details

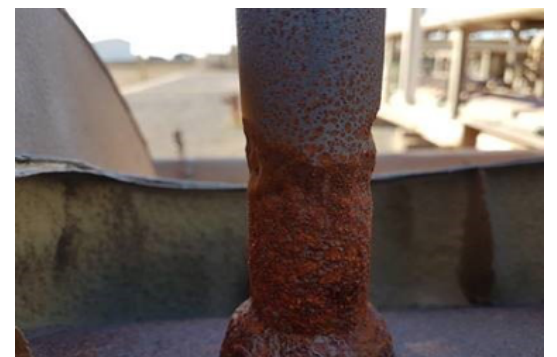
Inspections at an ammonia plant in Australia revealed external metal loss had led to a pin hole in a 1-inch (25-mm) Schedule 40 pipe, and additional areas of the pipe wall were showing signs of significant wall thinning.

*Area of external metal loss*

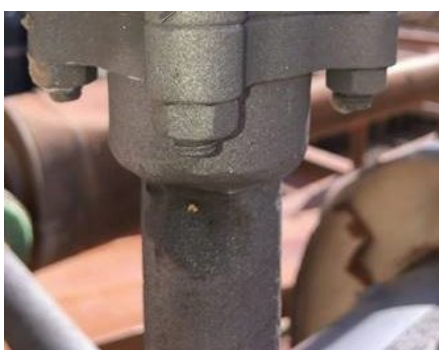
*Pinhole plugged*

Clock Spring trained and certified technicians plugged the pinhole and applied a fast-curing liquid metal over the plug. When the liquid metal was cured, the team grit blasted the line to SA2.5, removing all rust, coating, and mill scale to produce a near-white surface, and washed it with solvent before applying 4 layers of Clock Spring Contour.

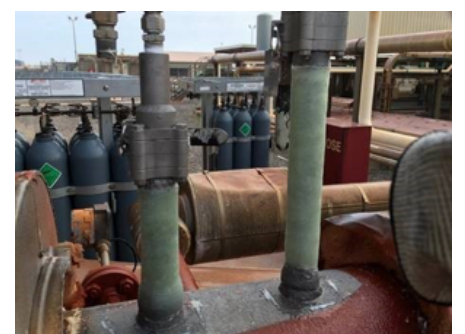
*Pin Hole Completed repair*

With the repair complete, the line could be returned to service, and the plant could continue safe operations.
