# Contour Solves Corrosion Issue in High-Temperature Line

United States

### Pipe Details

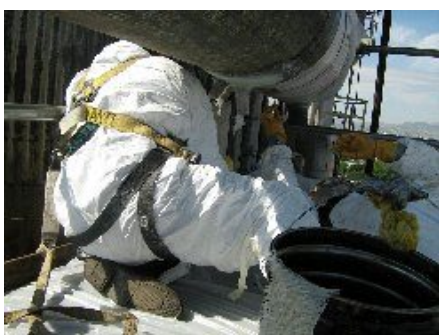
*Converting nozzle area with composite box*

A team of Clock Spring trained and certified technicians ring blasted each end of the damaged section of pipe, hand sanding thin areas to prepare the surface for the Contour repair. When the pipe surface was ready for the repair application, the team filled the nozzles with Contour glass/epoxy and filled the nozzle area with insulation to form a rounded box. With the box in place, they wrapped the entire line with Contour, executing a repair to ISO TS 24817 specifications. Throughout the repair, the line remained in service at 270° F (132° C).

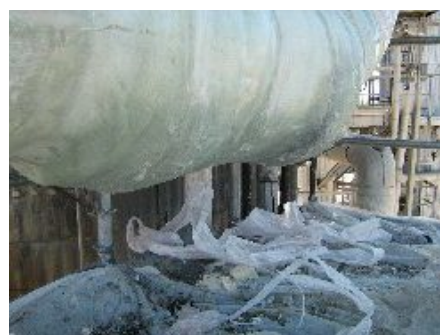
*Application of contour to nozzles*

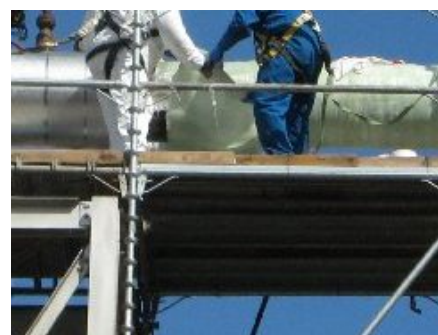
*Wrapping Contour*

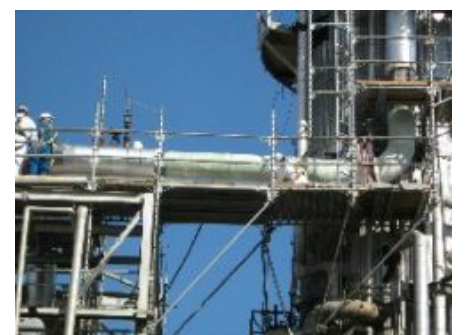
*Wrapping contour for 20' from ring blast on horizontal to ring blase above 90°*

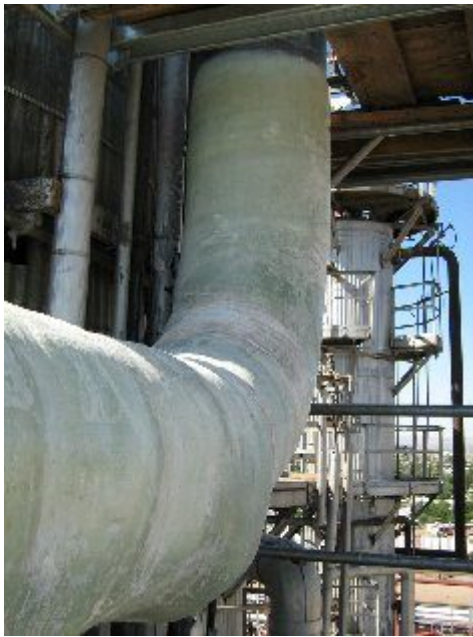
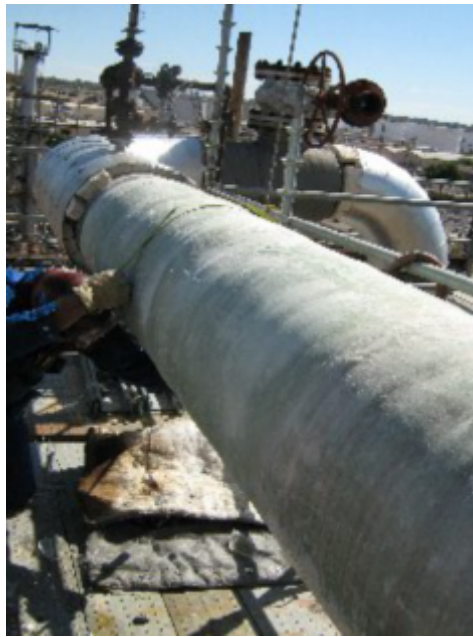
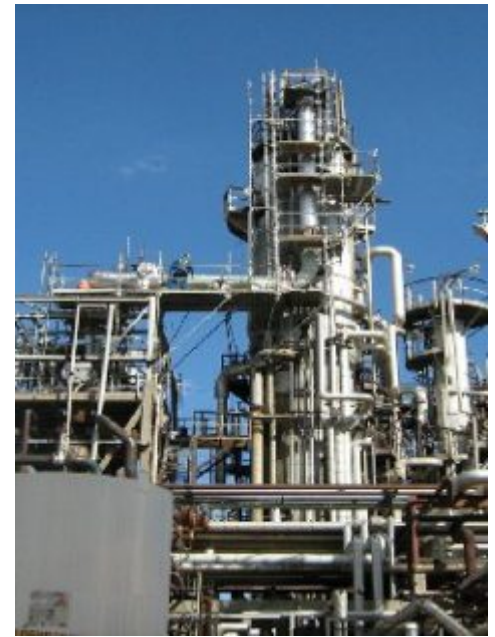
*Contour Job Complete*

The 6-foot (1.8 m) area of line that was severely thinned was considered disbonded and was expected to disappear during the life of the repair, estimated at 4 years. With the pipe fully eroded, the Clock Spring Contour repair is designed to manage the pipe hoop, axial and deadweight loads and provide pressure containment.
