# Contour Tackles Complex Geometry on Ammonia Lines

South Korea

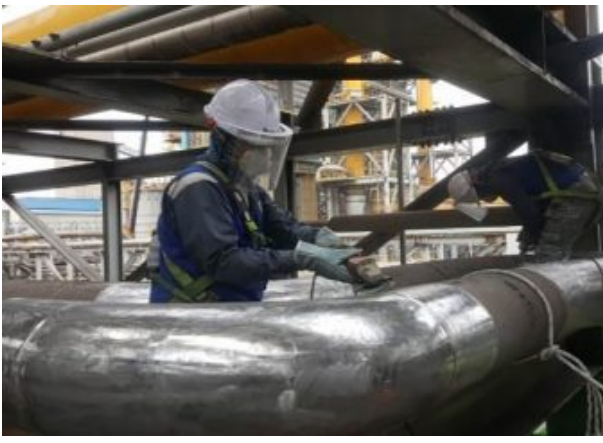
*Installers from Dong-buk E&C prepare the surface of the pipe for the Contour repair.*

A team of 6 Clock Spring trained and certified installers from Dong-buk E&C applied 5 layers of Contour to multiple leaks ranging from 1 mm to 5mm (0.04 – 0.2 inch) in length. Each area was filled with Clock Spring's proprietary filler before being overlaid with fiberglass cloth.

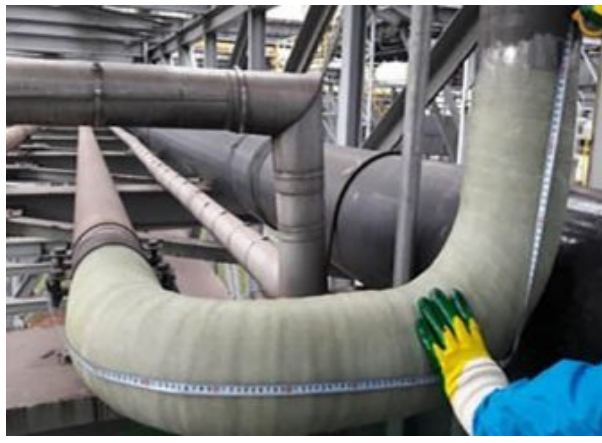
*The installation team applies the Contour fiberglass cloth to the pipeline.*

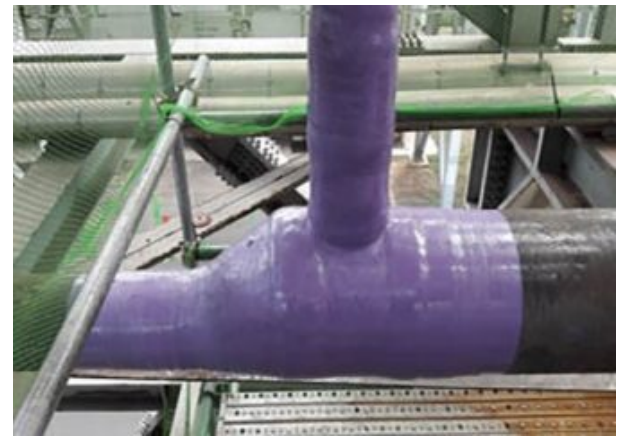
*The Clock Spring Contour repair restores the line to safety.*

All 147 repairs were completed in 15 days with a solution that was quick to deploy, easy to install and will last for decades.
