# DiamondWrap® SubSea™ Riser Rehabilitation in Caribbean

Customer: Buckeye Bahamas Hub

Location: Freeport, Bahamas

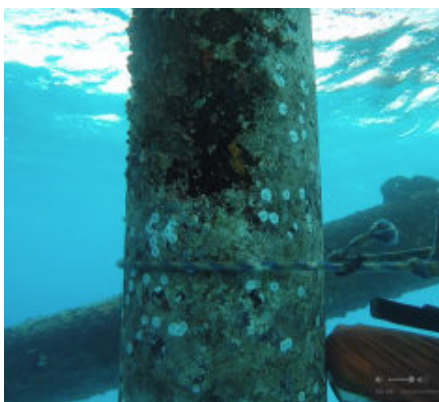
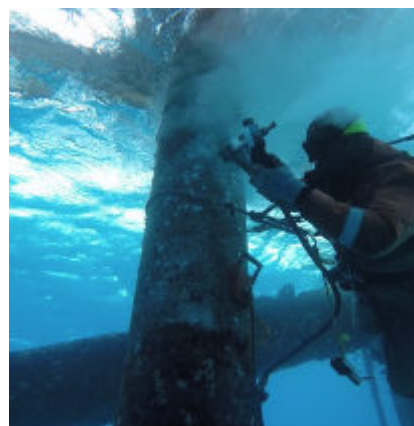
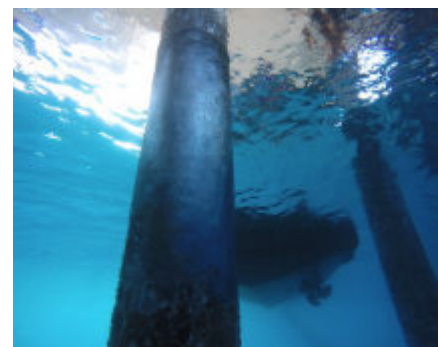
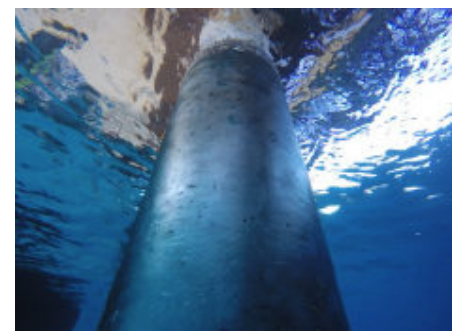
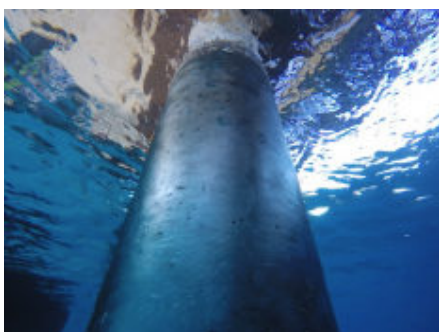
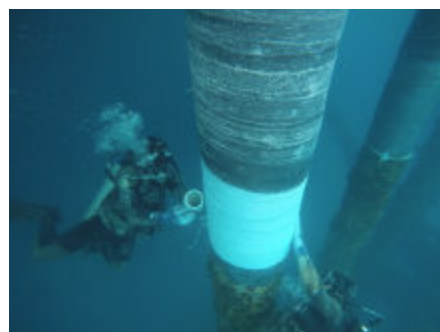
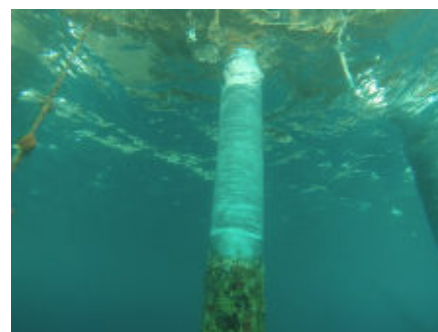
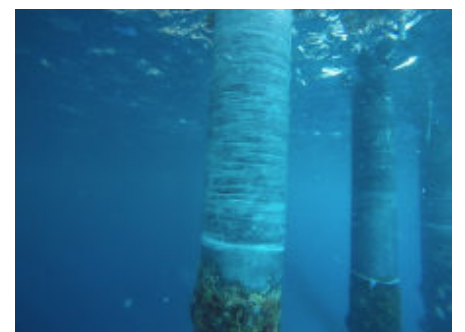
A team of trained and certified installers layered carbon fiber over the specified repair area, according to the calculations prepared by the Citadel Technologies engineer. No heavy equipment or hot work was required for the installation, and the line was in operation with no disruption in production. Below are photos of the completed repair:

Citadel Technologies' team of engineers designed repairs for each riser according to ASME PCC-2 Article 4.1, and recommended a DiamondWrap® SubSea™ repair solution. 11 kits of DiamondWrap® SubSea™ were required to repair the defects, one kit on each corroded riser.
