Composite Technology Restores Riser Integrity

By Buddy Powers, ClockSpring|NRI

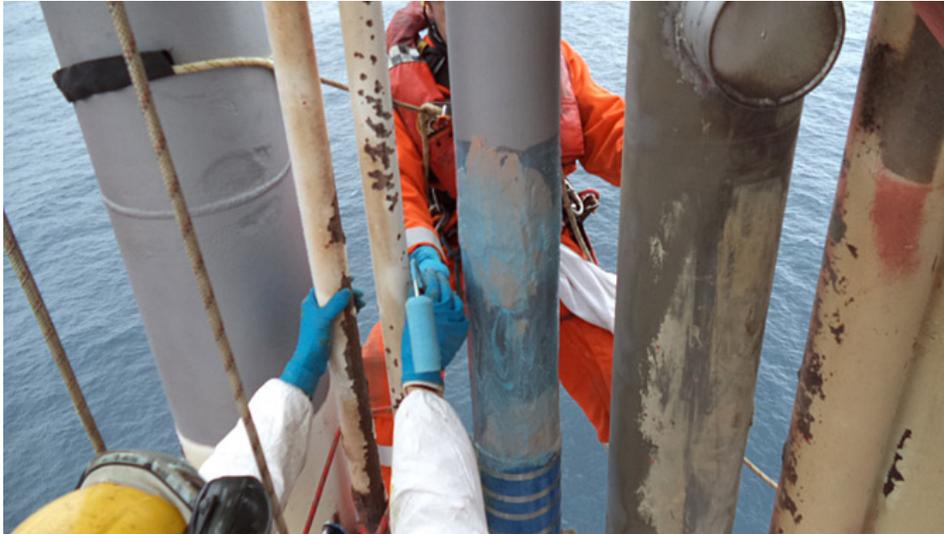
Using rollers to apply adhesive, the installation team places and secures composite sleeves on the riser (photo: ClockSpring|NRI)

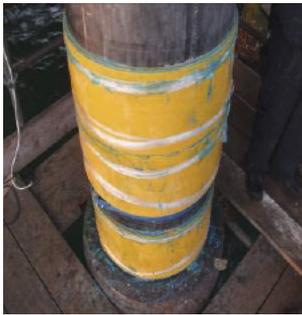
The completed repair with Clock Spring sleeves installed both below and on top of the welded steel sleeve (photo: ClockSpring | NRI)

With the second Clock Spring repair sleeve installed, the gap between them was ready to be filled. The installation team applied filler over the two welds and affixed the molds, tightening them to force the filler into the natural circumference of the pipe. When the mold was removed, they sanded the cured filler and refilled the voids, allowing the new filler to cure. This created a new surface that would allow the composite sleeve to be installed without voids and cavities. This precaution allowed the Clock Spring to retain its hoop stress.

With the two weld bridges completed, the final stage of the installation was carried out. The team cleaned the repair sleeves in readiness for the corrosion coating and applied primer to the joints on the sleeves, allowing it to cure before applying the final coating. The flanges and both clamps also were coated to create a fully coated finished surface.
