Composite restores FPSO integrity

By Sean Connolly, ClockSpring | NRI

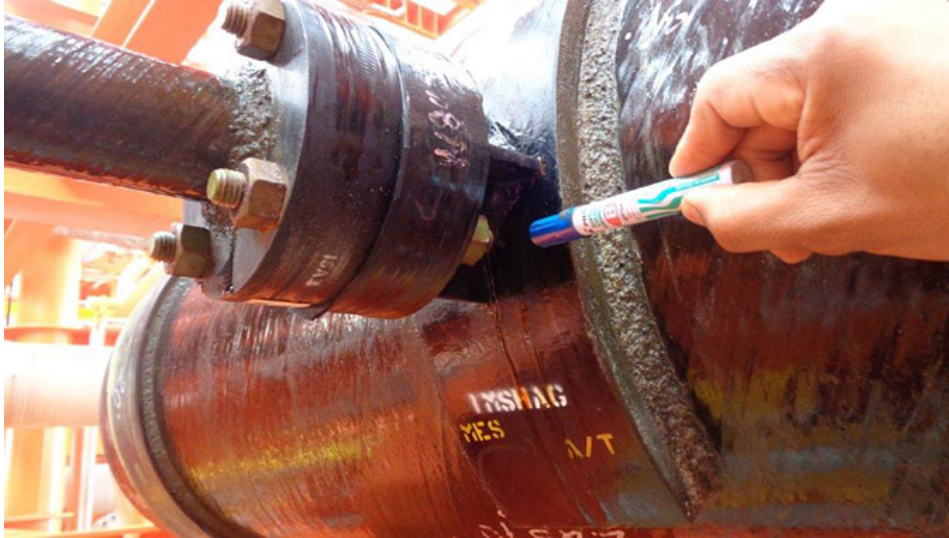
A leak is detected on a joint between a 508-mm (20-inch) and 51-mm (2-inch) GRE branch line (photos courtesy of ClockSpring | NRI)

When an operator discovered leaks on several live glass reinforced epoxy (GRE) cooling water lines on an FPSO offshore Angola, decisions were made to take immediate steps to mitigate the damage. Stress and internal erosion had led to cracks and through wall defects in several places, including a joint. A repair solution was needed that would arrest the leaks and restore the line integrity for continued safe service.

The first step in the repair process was to use a proprietary composite injection system to arrest the live leaks and Syntho-Poxy™ 101 to improve the complex geometry of the lines. With this step completed, technicians applied eight layers of the Thermo-Wrap™ Inspectable system on the 355-mm (14-inch) line and 10 layers on the 51-mm (2-inch) branch. Within 8 hours, the repairs were fully cured, and the lines were safe for continued service.

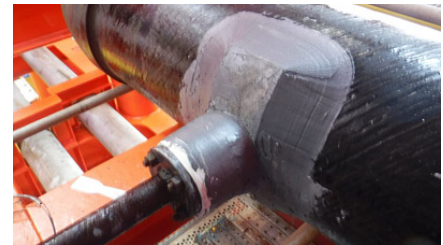
Technicians used a proprietary composite injection system to arrest the live leaks and Syntho-Poxy™ 101 to improve the complex geometry of the lines

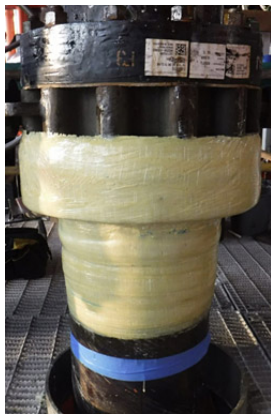
With the leak sealed, technicians applied 8 layers of the Thermo-Wrap™ Inspectable ECR to the 355-mm (14-inch) line

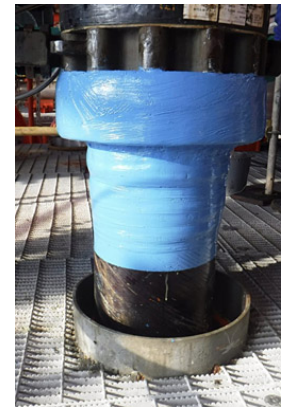
In the final step of the 355-mm (14-inch) line repair, technicians applied 2 layers of UV stable epoxy to protect the repair from future corrosion and abrasion
