COMPOSITE REPAIRS

This was the solution to a challenging repair undertaken by an Alaskan pipe operator that needed to address damage to 20 girth weld joints on a 10in (254mm) gas pipeline in Cook Inlet. The line needed to be repaired without disrupting service, but that was only one of many considerations that had to be taken into account in the operation.

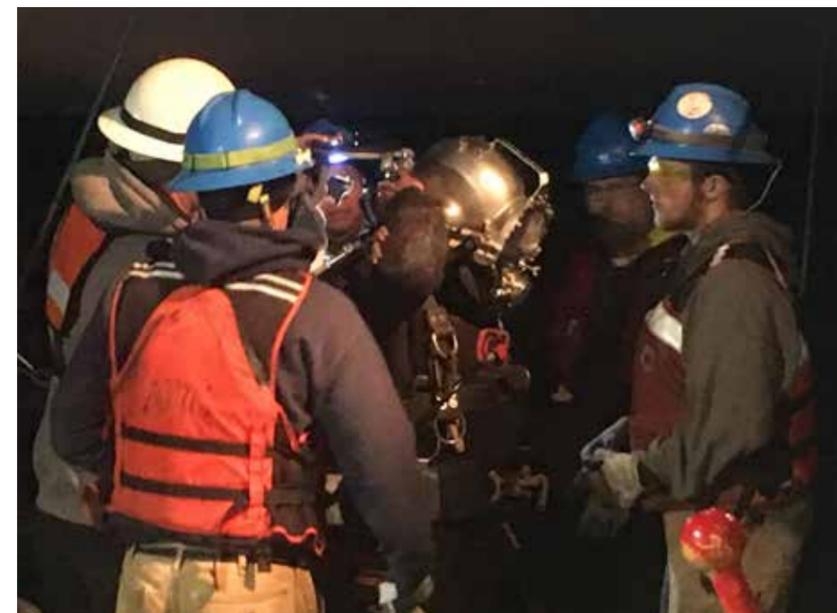
Because of the narrow work window and the zero visibility conditions at depth, some dives were scheduled to take place at night
