BEACON STREET PIPELINE REHABILITATION

Project Overview	
Project	Beacon Street Water Pipeline Repair
Location	Boston, Massachusetts
Owner	Massachusetts Water Resources Authority
Host Pipe	Cast iron
Diameter	48 inches
Length	72 linear feet
Operating Pressure	150 psi
Product	Tyfo® SCH-41-2x

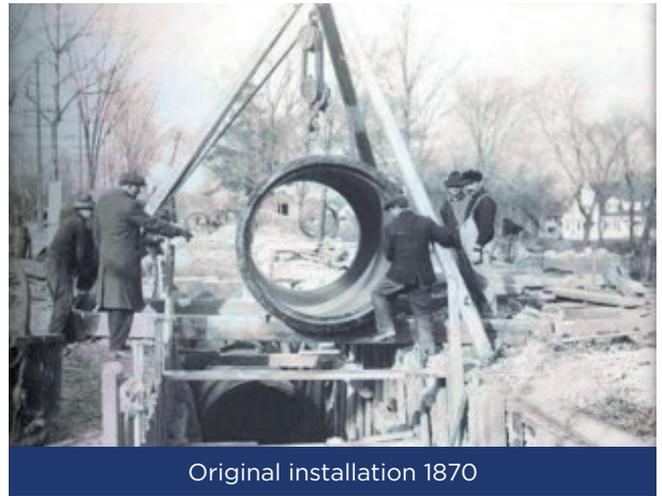
Original installation 1870

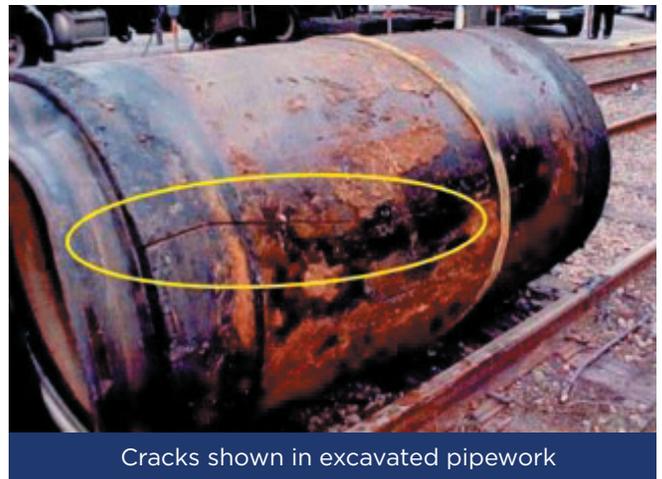
Cracks shown in excavated pipework

The cast iron water main was rehabilitated by Fibrwrap Construction for the MWRA using Tyfo® SCH-41-2x on-time and on-budget. This example demonstrates the flexibility offered by the Tyfo® system compared to other trenchless rehabilitation systems in large-diameter potable water mains.
