# PENSTOCK REHABILITATION USING CFRP

## Ontario, Canada

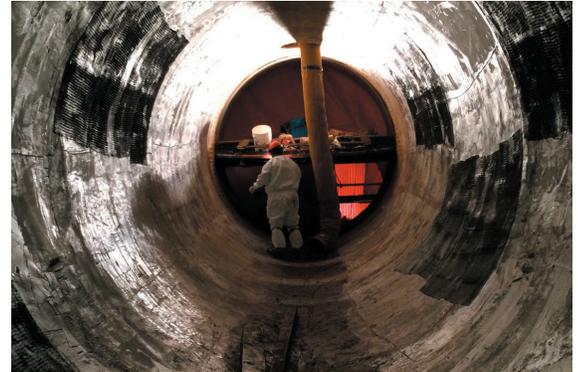
Interior of pipe with CFRP liner

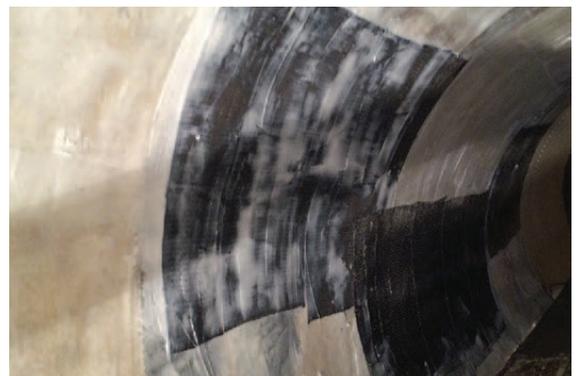
CFRP liner applied

Once Mississippi River Power approved the design, installation of the FRP was completed by Fyfe Company's certified FRP applicator, Fibrwrap Construction. Prior to the FRP application, Fibrwrap Construction hydroblasted all concrete surfaces receiving FRP to achieve the minimum ICRI concrete surface profile (CSP) level 3, defined as a uniform exposure of the core's coarse aggregate such that the surface will be void of latent materials. The materials were then applied with an epoxy using the wet layup method. These materials included Tyfo® SEH 51A (GFRP) over all exposed steel surfaces and Tyfo® SCH 41-2X (CFRP) in all other areas.

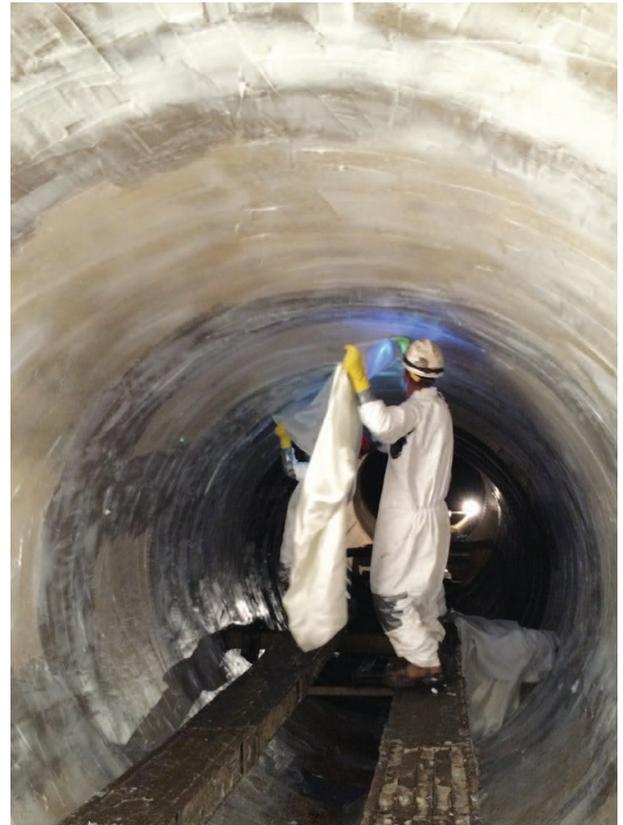
Applying FRP to hydroblasted concrete

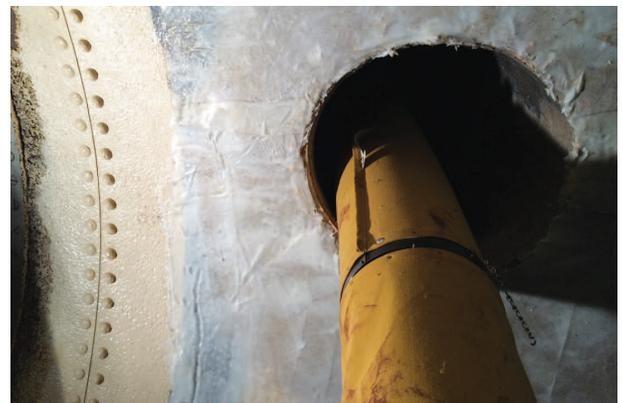
The project faced a variety of challenges during the project including leaks and water infiltration. Eliminating these leaks was critical to the success of this project, so leaks were repaired prior to installation, and water infiltration addressed throughout the course of installation.

Leak repair
