ThermoWrap® MT Meets Challenge of Aging North Sea Pipeline System

North Sea

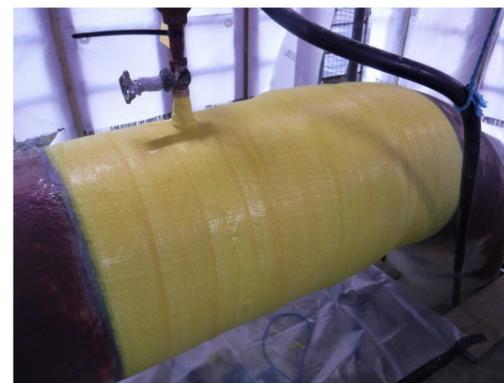
As a fiberglass wrap, ThermoWrap MT can be applied easily in areas of limited access. It also conforms well to complex geometries.

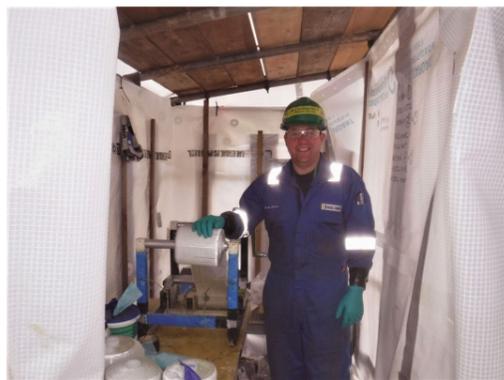
Habitats were built to protect the repair area and to maintain temperature to ensure the correct cure cycle of the ThermoWrap MT repair.

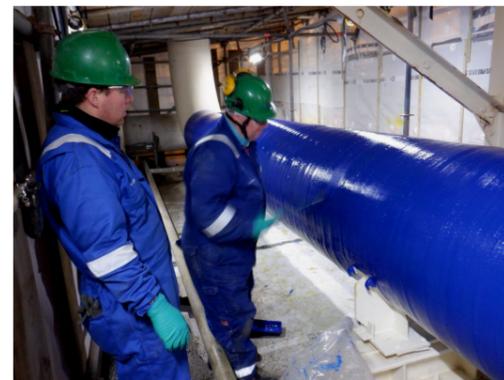
As part of a two-part epoxy system, an exterior blue coat of epoxy is applied to protect the repair from exposure and future corrosion.
