Corroded Offshore Riser Repaired with A+ Wrap™

Offshore

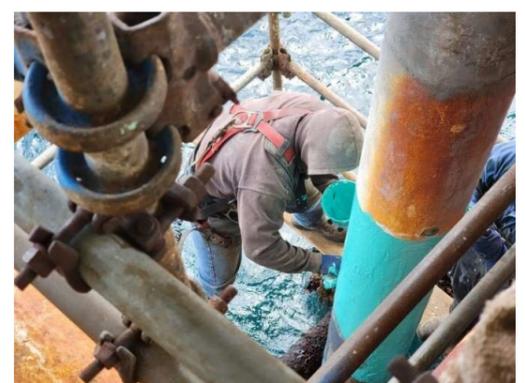
A 12-inch carbon steel pipeline riser located on a permanent offshore platform had experienced highly visible exterior corrosion over a five-foot straight segment. The external wall loss depth was approximately 0.36 inches. The repair location posed challenging access and wet conditions. In addition to restoring strength, the repair needed to provide protection against future corrosion in a salt-water environment.

The repair area was cleaned and filled, followed by an underwater primer applied to all exposed pipe areas.

Prior to application, the repair area was media blasted and surface cleaned. A high-compressive filler was applied to the damaged area, followed by an adhesive primer applied to all exposed pipe. After a brief waiting period, the crew applied the A+ Wrap by spiral-wrapping the pipe. The six-inch fabric width made application more manageable in the difficult-to-access area. The wrap was followed by compression film and then perforated to allow for natural off-gassing. The repair was allowed to cure overnight. The next day, SynthoGlass SPF was applied over the cured repair to protect the installation from UV degradation and future corrosion.

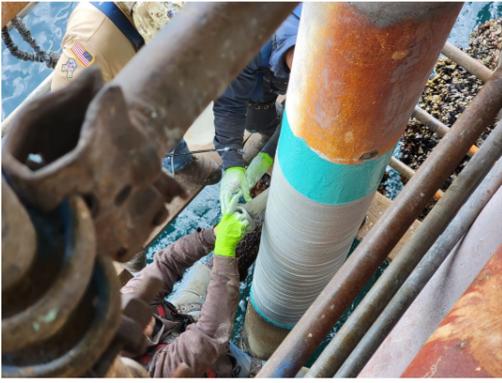
A+ Wrap is compatible with wet conditions and can even be applied under water.

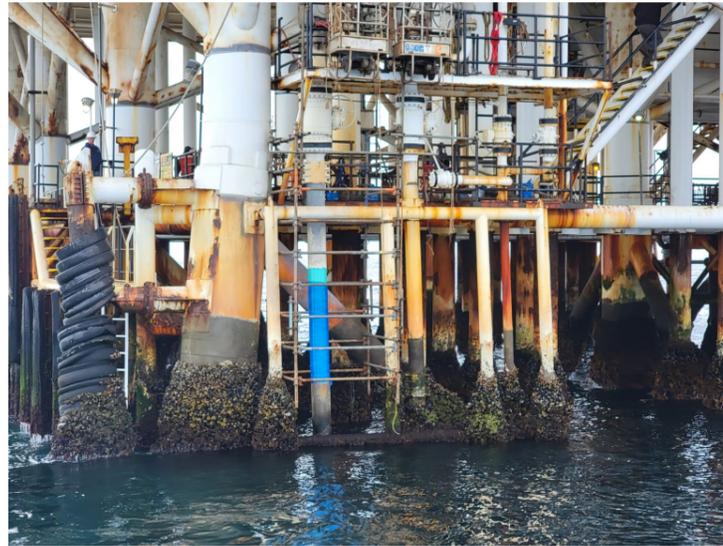
Compression wrap was applied over the A+ Wrap and allowed to cure overnight.

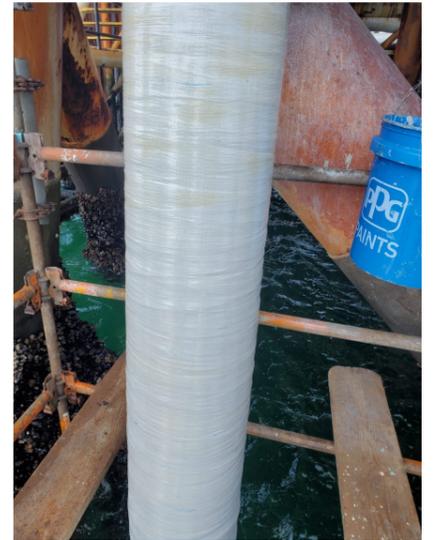
Completed A+ Wrap repair is a permanent repair that will virtually eliminate instances of future corrosion
