# DiamondWrap<sup>®</sup> MT Restores Bath Heater to Safe Service

Pennsylvania

### **PIPE DETAILS**

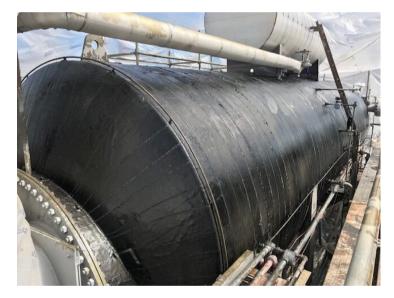
The flexibility and low profile of the DiamondWrap composite system allow installation even in areas with limited clearance. (Photo courtesy of CSNRI)

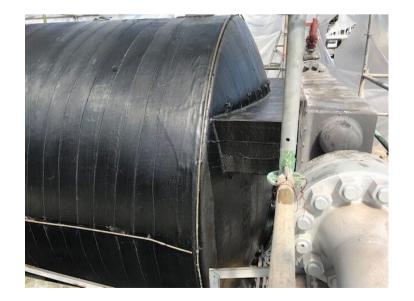
DiamondWrap can be installed on tees, elbows, and varied geometry without compromising the integrity of the repair. (Photo courtesy of CSNRI) Although the bath heater was under low pressure, the unit needed to be stable under operating temperatures up to 300°F (149°C). The DiamondWrap system with a high-temperature epoxy was an ideal solution. This repair uses a bidirectional weave of carbon fiber and a 100% solids epoxy to create a composite that is stronger than steel.

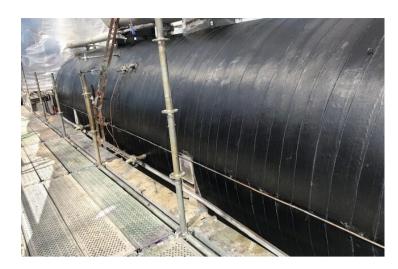
The composite system forms a pipe around a pipe, and each successive wrap increases the pressure rating, creating a finished repair that is stronger than steel.
