Atlas Provides Quick Dent Repair Solution for Liquids Pipeline

USA

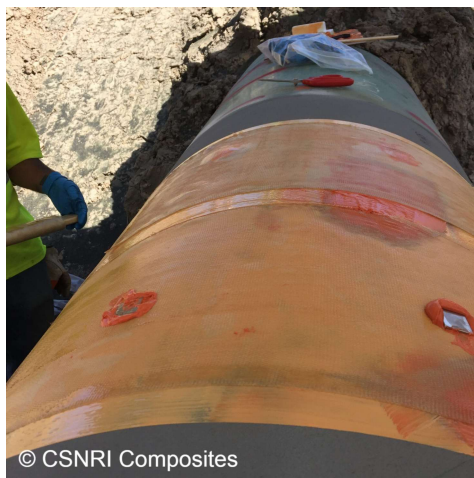
ILI smart pig markers were put in place for easy monitoring of the repair.

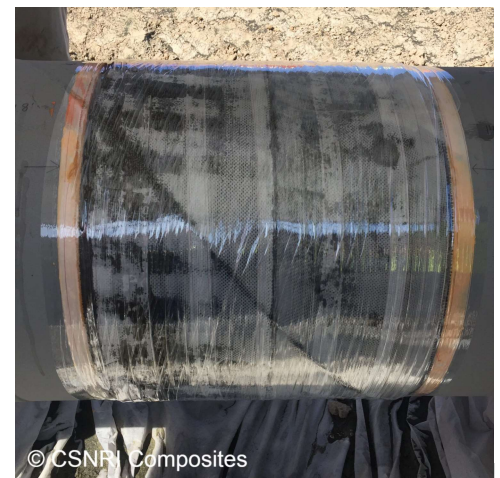
The Atlas repair is wrapped with a protective wrap prior to curing.

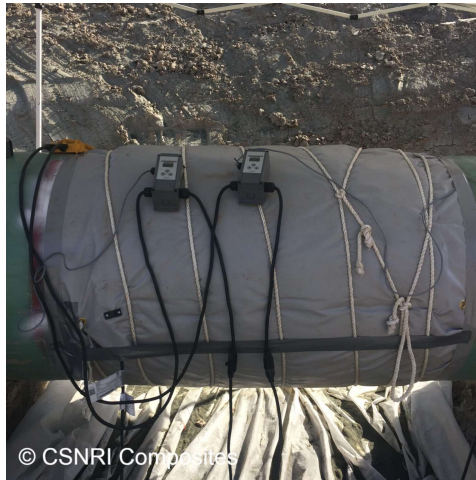
A heat blanket was applied over the constrictor wrap to expedite the curing process.

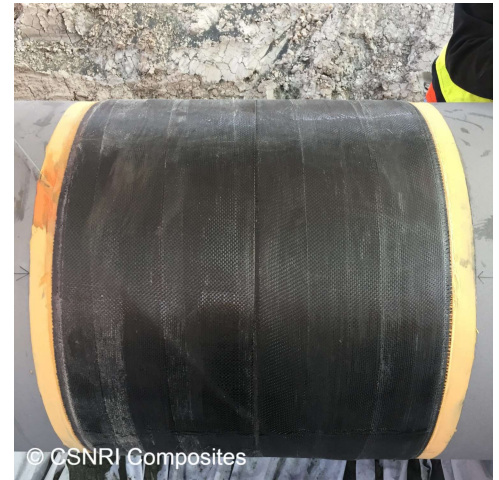
The completed Atlas repair fully restored structural integrity and pipe function.
