# 100-YEAR-OLD PENSTOCK GIVEN NEW LEASE OF LIFE BY TYFO SYSTEM

Location: Town of Dryden, Ontario, Canada

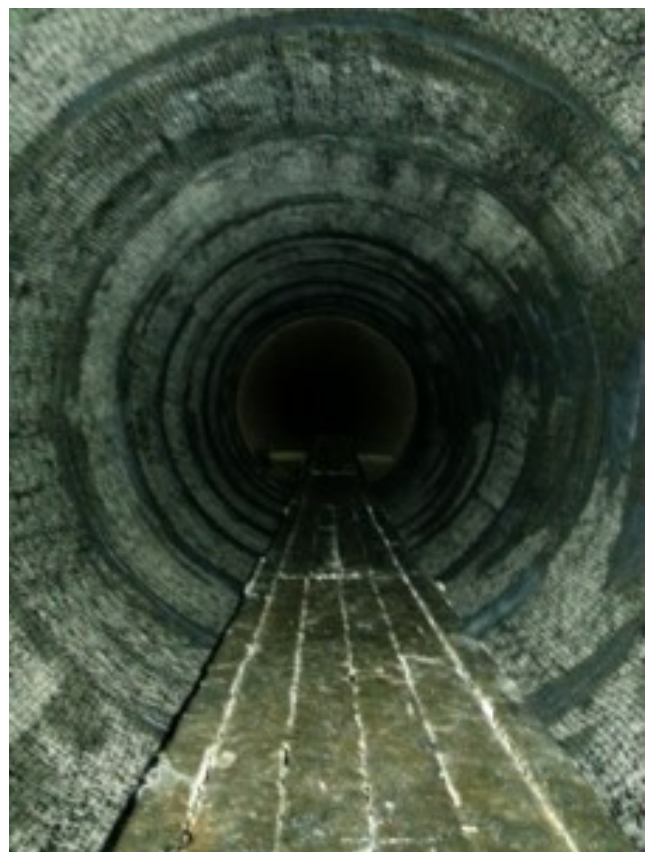
Eagle River Station penstock after rehabilitation with Tyfo FRP System

Once the FRP installation was completed a skim coat of thickened epoxy was applied over the FRP material to provide durability and longevity to the repairs. The installation of the FRP system at Eagle River Station was completed in just seven days allowing the owner to return the unit to service.
