100-YEAR-OLD PENSTOCK GIVEN NEW LEASE OF LIFE BY TYFO SYSTEM

Location: Town of Dryden, Ontario, Canada

The Eagle River Generation Station is a hydroelectric generating station located near the Town of Dryden, Ontario, Canada. Eagle River, in addition to McKenzie and Wainwright stations, provide a combined 3.9 MW of energy to the local power grid. These generating stations make up Dryden Hydro and are owned by the Capstone Infrastructure Corporation. Built in 1920s, the 120-inch diameter riveted steel penstock delivers water from Eagle River to the hydro turbine.

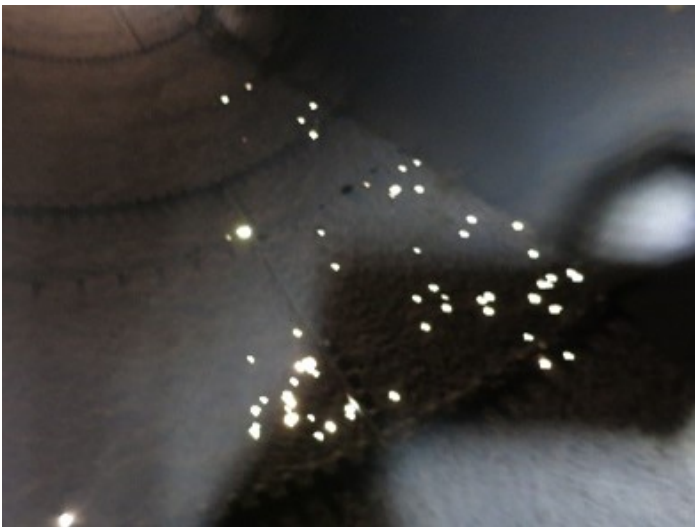
The Eagle River penstock is aboveground, supported on concrete piers and exposed everywhere except for the end terminations which are encased in concrete. KSS Group assessed steel thickness and identified deficiencies, which included severe wall loss and holes through the pipe wall. The assessment concluded that the steel pipe required immediate rehabilitation for a 72.5-foot long section between the intake structure and the powerhouse.

Eagle River Station penstock before rehabilitation showing holes
