GEOSPRAY® 61

Geopolymer Mortar

Geopolymer Rehabilitation of Storm Drain, Chula Vista, CA

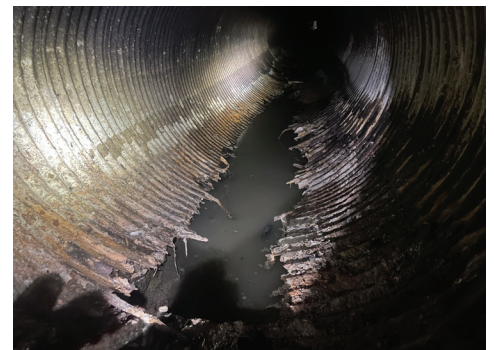
The City of Chula Vista located in Southern California identified a 720 linear foot section of 66-inch CMP storm drain was experiencing a rapid deterioration of the structure including the corrosion of invert, ovality of the pipe and ground water infiltration.

Cleaning of the storm drain revealed that the invert was severely corroded, and approximately one to two feet width of the CMP pipe was missing throughout the entire 720 -foot reach. A new concrete invert was poured to fill the voids and bridge the gaps in the CMP pipe. Locally sourced 3,250 PSI concrete was used and allowed to cure.

Storm drain experiencing rapid deterioration of the structure including the corrosion of invert, ovality of the pipe and ground water infiltration

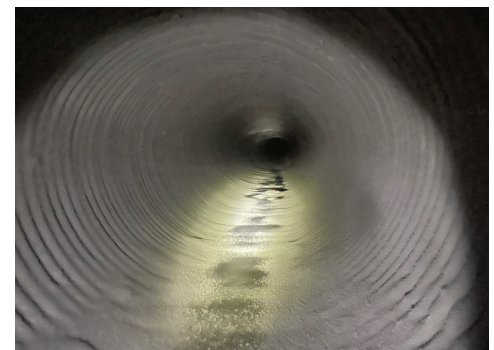
Chula Vista storm drain after rehabilitation. Spincast layer of GeoSpray geopolymer to create a new pipe-within-a-pipe.

After grouting was complete, and infiltration was stopped, the pipe was ready for spincasting. The pumper/mixer assembly is placed near the access manhole along with pallets of pre-mixed dry material supplied in 50-pound bags. Concrete hoses were run from the pump into the manhole and through the pipe to the spinner sled at the far end of the pipe segment to be lined. The geopolymer dry mix is mixed with a measured amount of water as it leaves the pump, and travels through the hoses to the spinner sled. A winch is used to pull the spinner sled back at a controlled speed to ensure the correct amount of geopolymer was released. Multiple passes, or lifts of material, are usually required to reach the design thickness, with an initial thinner lift often required in CMP to allow for better bonding of future, thicker, lifts.
