# BUCKLED AND DEFORMED PENSTOCK REHABILITATION TO RESOLVE POWER GENERATION ISSUE

*Location: Almonte, Ontario, Canada*

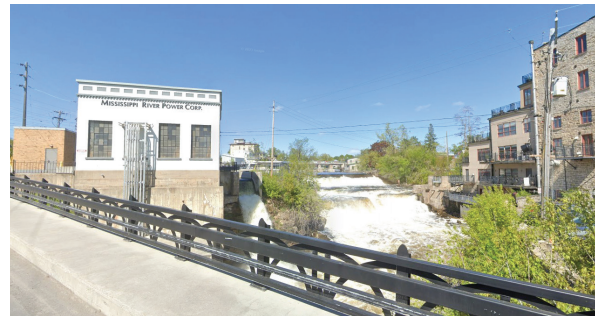
In 2012, power output dropped at the Mississippi River Power Corp.'s 4.6-MW Brian J. Gallagher Generating Station, on the Mississippi River in Ontario, Canada. The turbine was taken offline, inspected and found to be in good condition. The facility's owner examined the 106-inch diameter penstock to discover it was partially blocked. The steel lining had delaminated in the rectangular transition section, causing the 3/8" thick steel liner plates to buckle and deform throughout the concrete-encased pipe.
