ThermoWrap® MT Repairs Corroded Vent Stacks Extending Service Life beyond Decommissioning Date

Northern UK

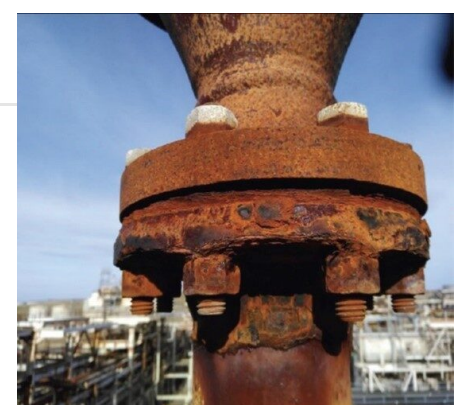
Inspection of stacks revealed extreme external corrosion on OWS vent lines.

Severe external corrosion was visible on each of the six oil-water separator (OWS) system vent lines. The remaining wall thickness ranged from 3.0 mm to 1.2 mm. The locations of the six repairs posed challenging access. An on-site scaffold contractor installed temporary steel restraints to prevent any excessive movement of the vents during repair once the U bolts. Further tie backs were used to hold the vents away from the L shaped bar-type support and allow 360-degree repair of the entire section of line.

With varying degrees of corrosive damage and wall thickness, and as a conservative measure, the repair design was performed in accordance with the ISO24817 standard Type-B analysis. CSNRI engineers recommended a system to reinforce the defected areas with a six-layer application of ThermoWrap MT. The solution was engineered to restore the line to its design capacity and extend the service life of the six stacks. ThermoWrap MT is an engineered, field-saturated repair system made of proprietary fiberglass cloth applied with a two-part epoxy and a high-modulus filler material. It is used globally in plants, refineries, tank farms, terminals and on offshore assets as a pressure-containing repair to seal leaks and as a reinforcing repair to restore the strength of a pipe in the axial and circumferential directions.

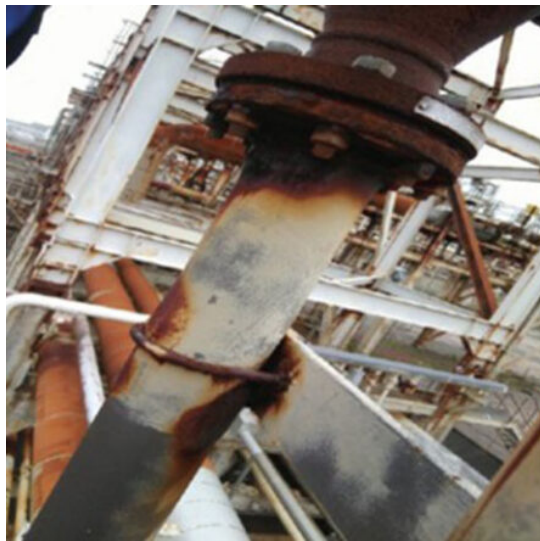
Using a cold-cut method, U-bolts were mechanically cut to improve accesses to areas of corrosion for application of ThermoWrap MT repair.

Due to the thick scabbing around the U-bolt locations, CSNRI technicians removed the U-bolt supports using cold cut methods which allowed the repairs to be extended past these locations. Additionally, as the line was positioned extremely close to the support removing the bolts allowed the repositioning of the line away from this restriction so that repair could be installed to the full 360 degrees of the lines.

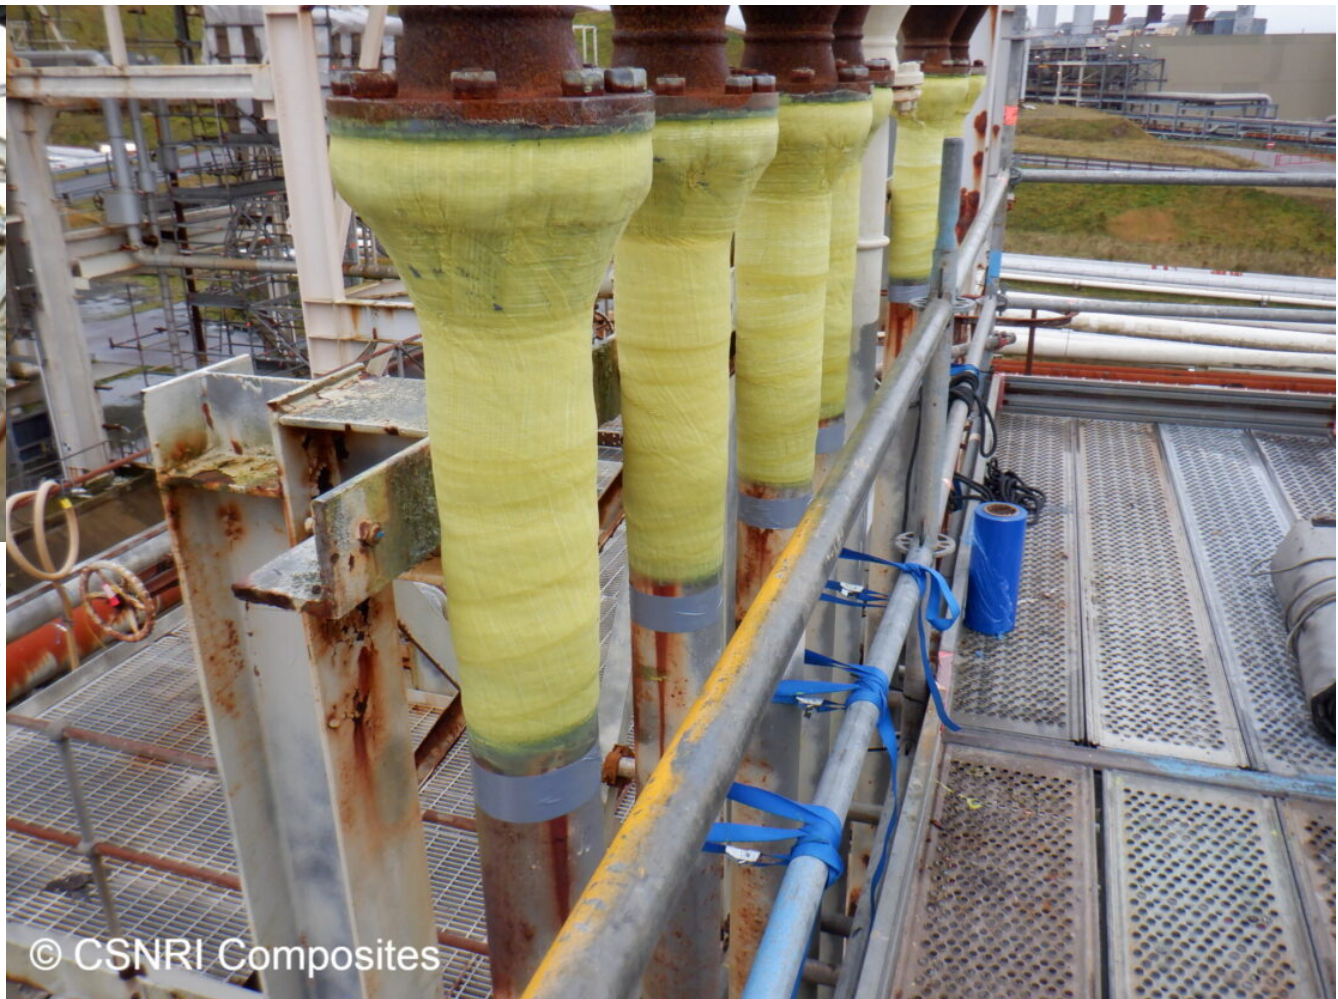
ThermoWrap MT® was field-saturated with six layers applied to each vent stack.

The repair area was then coated with an even layer of SFE-330, averaging 200 microns in thickness. The ThermoWrap MT material was saturated in the field with SFE-330 resin. Six layers were applied from the flange perimeter and onto the pipe at the opposite end. The original repair length was 300 mm for each location. Once the support was removed, further UT confirmed the wall thickness to be below T_{min} at the contact point. To restore wall thickness, the repair was extended to 600 mm. The repair was then encapsulated in six layers of compression film. A heater blanket was applied to the repair based on the following curing schedule: two hours at 40°C and six hours at 60°C. Once the curing cycle was completed, the lines were further coated in a UV-stable epoxy coating for additional protection against the harsh environmental conditions the lines are exposed to on an ongoing basis.

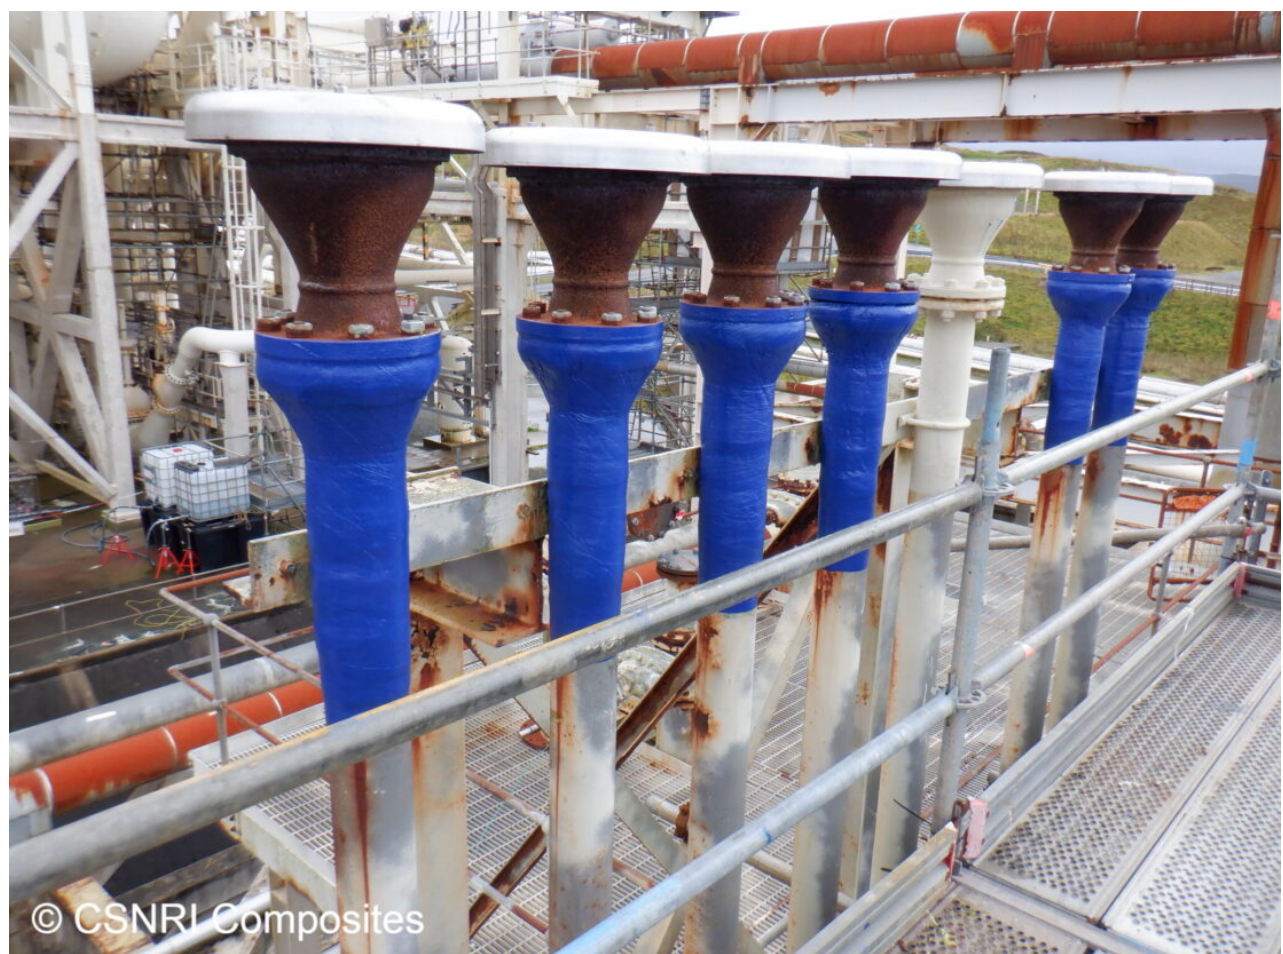
The six vent stacks were fully repaired, restoring structural and operational integrity to the line. The repair was completed in 2 days without interruption to facility operations. QC/QA protocols indicate that a Shore D hardness of 85 was achieved. The lines are fully operational and the repairs are expected to provide the required integrity until retirement date of the system.

The final repair received an epoxy UV coating for additional protection from harsh weather conditions that are typical of the northern UK area.
