LARNACA SEWAGE TREATMENT PLANT TANK REHABILITATION

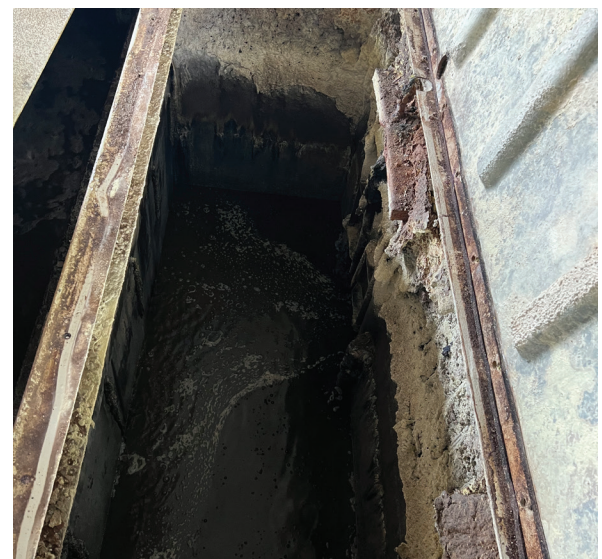
When initially constructed the tanks were coated with epoxy paint. In the short time the tanks have been in use, the highly corrosive sewage has eaten away the protective paint and concrete and left the tanks with exposed rebar which also started to corrode.

Heavily corroded treatment tank

operate, allowing the facility's operations to be unaffected. The chambers were then water blasted clean, all deteriorated concrete was removed, and repairs were made to the corroded rebar with a concrete mortar applied to build up the affected areas. Once this was completed the Tyfo systems were applied.

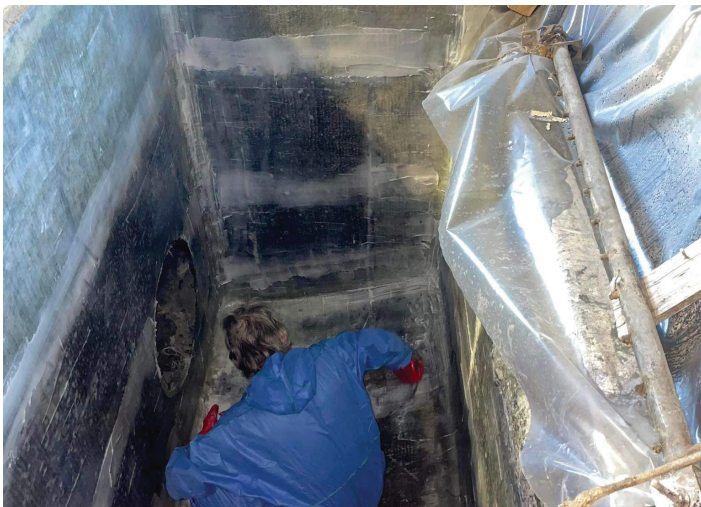
Application of Tyfo system

Together, Fyfe and quakeGuard worked to engineer a solution to the issue with a decision made to use Fyfe's SEH-31A glass fabric with Tyfo® S epoxy with the Tyfo HCR as a high corrosion resistant final coating and finish.

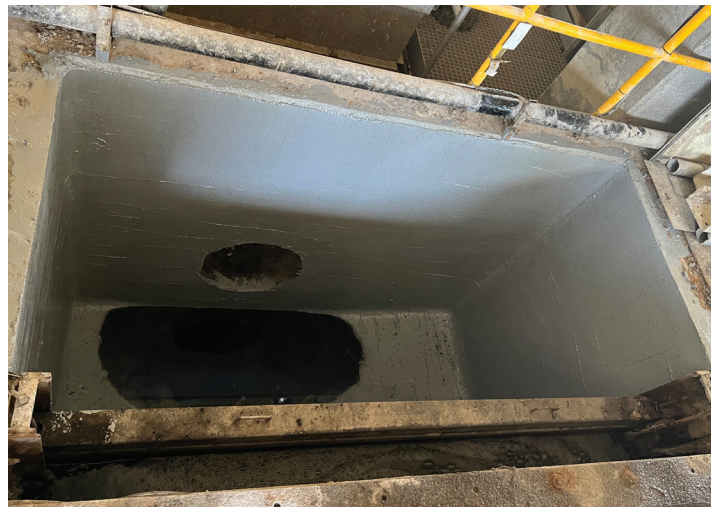
Completed rehabilitation of tank

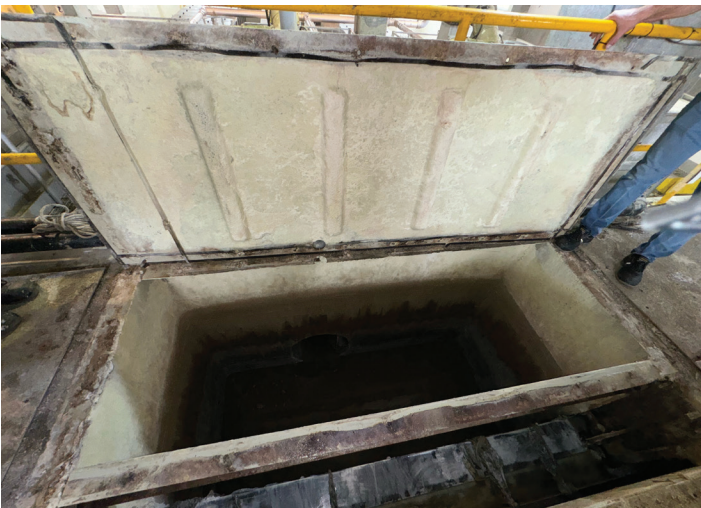
To ensure the 10-year guarantee, Kleopas and his team visit every two years to inspect the quality of the repair and, at their last visit, were pleased to see that no further corrosion has taken place, and the Tyfo FRP system looks as good as new.

Tank inspection after two years in use
