# BlackDiamond® 12" Dent/Gouge Repair in USA

### Pipe Details

- Customer: Gas Transmission Company
- Pipe Diameter: 12"
- Design Pressure: 255 psi
- Pipe Contents: Natural Gas
- Pipe Defect: Dents with Gouges and External Pitting

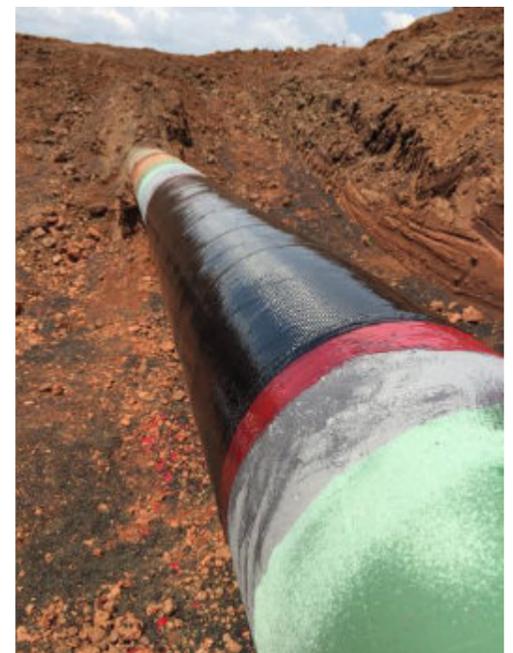
This gas transmission pipeline was suffering from dents with gouges and external pitting. Many miles of pipeline would have to be blocked in and purged in order to cut the line and weld in a fresh section of pipe. The company also could have welded on a "Type B" steel sleeve, but the result would be a costly repair with heavy equipment and lots of hot work, lost production time, and lost customer satisfaction.

CSNRI' team of engineers designed repairs for each defect according to ASME PCC-2 Article 4.1, and recommended a BlackDiamond® repair solution. Only 3 layers of BlackDiamond® were required to repair the defect, even with the type of anomaly that existed on the pipe.

CSNRI mobilized a trainer on-site to conduct the training and supervise the installation. The ambient temperature was 100 degrees Fahrenheit, creating a tough environment for installation. Once trained, the small team of newly certified installers worked quickly in the heat to install 3 layers of carbon fiber over a 5 foot repair length, according to the calculations prepared by the CSNRI engineer. The actual installation time was less than an hour. No heavy equipment or hotwork was required for the installation, and the line remained in operation with no disruption in production. Below are photos of the completed repair.

The repair was inspected for defects, and then checked to ensure that a sufficient cure was achieved using a Shore D Hardness tester. Once the repair was sufficiently cured, it was coated, and the trench was backfilled.
