Clock Spring Composite Sleeve Repairs Wall-Thinned Pipe

Mexico

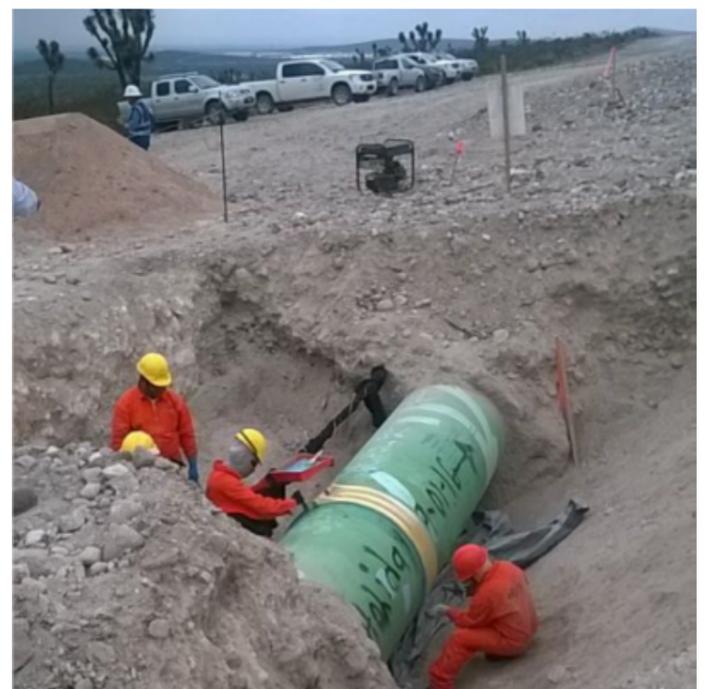
Composite Sleeve Repair

Following damage assessment by the Clock Spring team, the decision was made to install 9 sections of 42-inch (1,067-mm) and 9 sections of 16-inch (406.4-mm) Clock Spring coils over segments of line that exhibited wall loss. Certified Clock Spring technicians executed the repair, and in the process, trained the operator's employees on proper installation methods.

Using the coil pass as well as the spool feeder technique to contend with limited clearance underneath the large diameter line, the repair team installed each coil in less than 45 minutes, completing the installation without taking the line out of service.

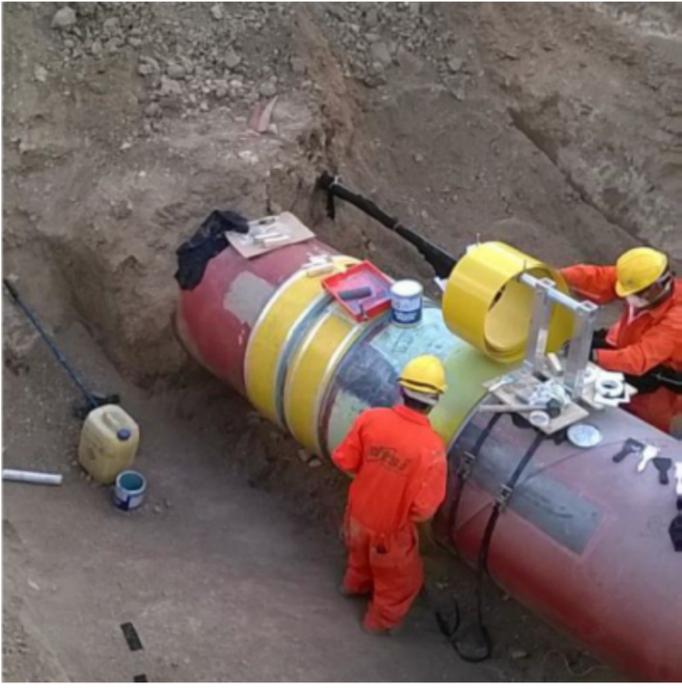
Composite Sleeve Repair

Following the application of the Clock Spring sleeves, marker bands were applied to the start and finish points of the overall repair using a simple installation technique. These marker bands provide a signature reference and are identified by an MFL* intelligent pig during future in-line inspections performed within the pipeline.

With all the sleeves installed and the markers properly positioned, the repaired section of pipe was cured for two hours. An operator-approved corrosion coating was applied over the complete repair area, and the line backfilled.
