Clock Spring Contour Repair Topside Piping System Corrosion

Pipe Details

- 26-inch (660-mm) topside production piping system
- Severe external corrosion

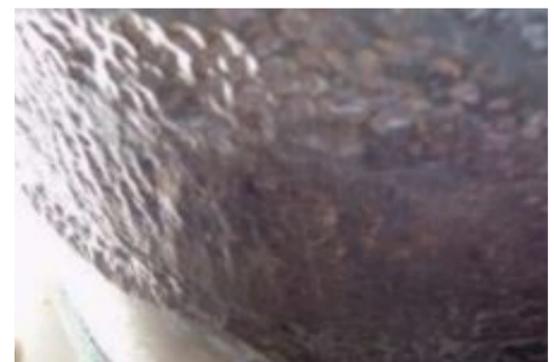
Completed pipework was subjected to severe external corrosion.

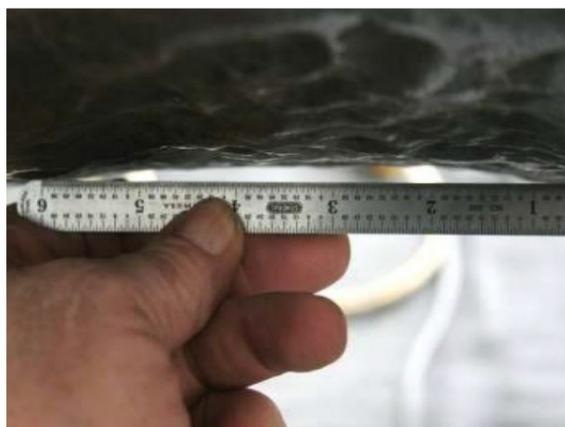
Affected area.

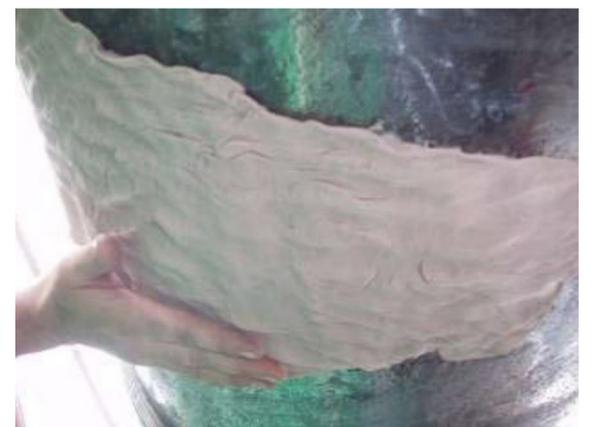
Due to the server extent of the corrosion the high compressive strength filler was initially hand applied
