Clock Spring Provides Permanent Repair to Damaged Refinery Pipeline

Pipe Details

- 8-inch (203-mm) diameter pipe
- Air/Gas mixture
- 900 feet (274 m) of pipeline

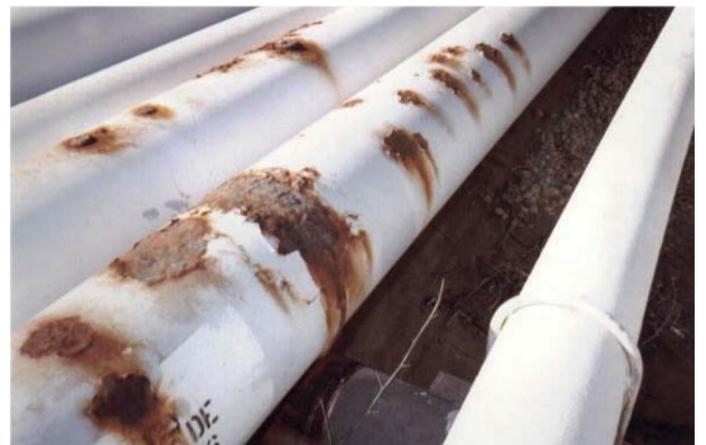
A US refinery discovered that a segment of aboveground pipeline had sustained corrosion from an airborne drift from a cooling tower. Damage was extensive. Corrosion spots covered 900 feet (274 m) of line that ran parallel to the tower.

Pipeline Corrosion

A team of Clock Spring trained technicians installed 903 Clock Spring units over 900 feet (274 m) of pipe at approximately 75 feet (23 m) to 100 feet (30 m) per day. As a cleaning crew prepped the pipe, three installation crews applied the Clock Spring to areas that included 90-degree and 45-degree fittings.

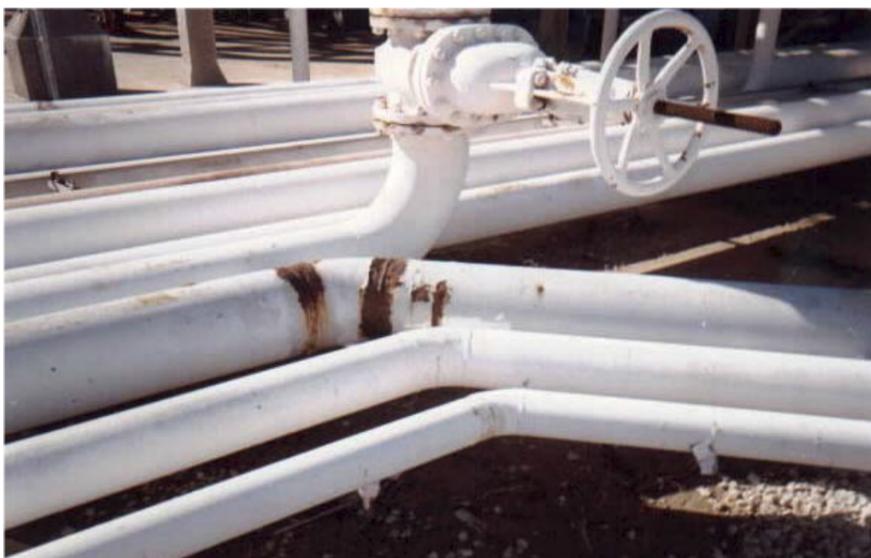
Pipeline Corrosion
