Clock Spring Repairs 42-inch Suction Line at Storage Terminal

Pipe Details

- 42-inch (1,067 mm) suction line at a storage terminal
- Extensive pitting and corrosion

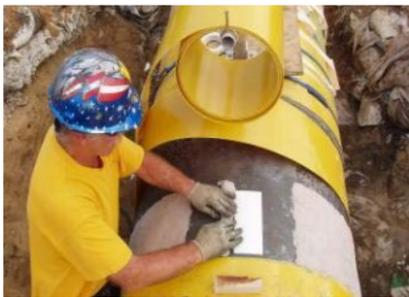
Starter pad application.

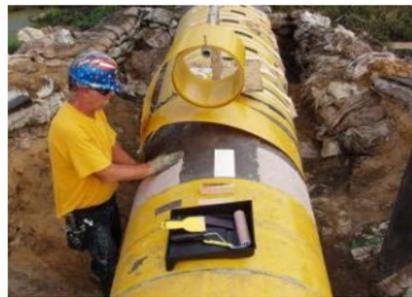
Filler application.

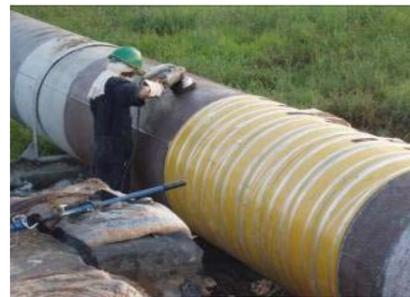
Pipe surface cleaned with solvent wipe.

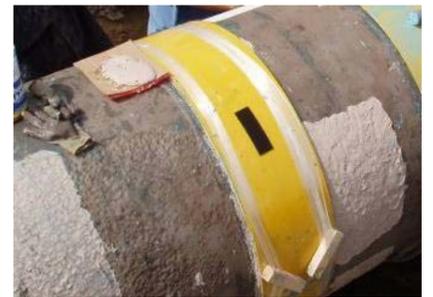
Additional area for filler application.

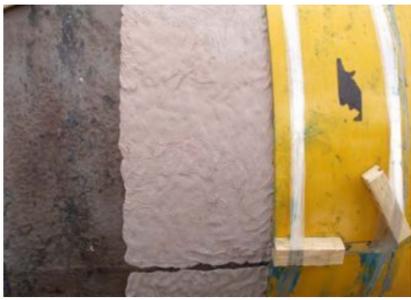
Additional area for filler application.

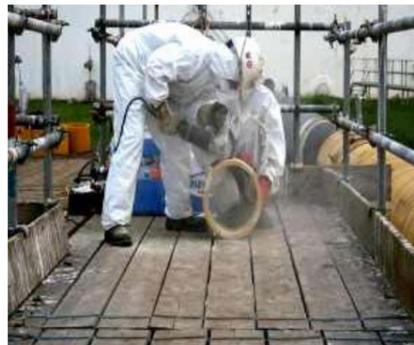
Installer cutting the coil to bridge the weld using diamond cutting disc.

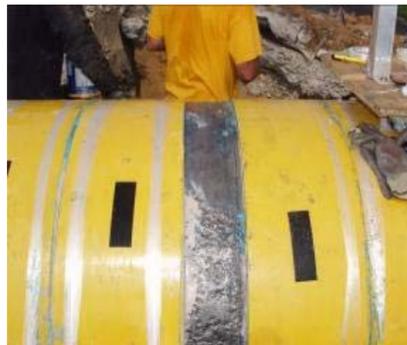
Bridged girth weld

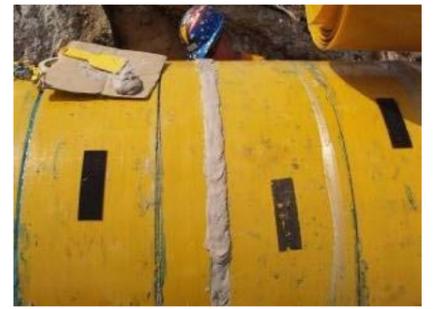
Gap filled in with filler solution. Clock Spring wrap will "bridge" over the joint.

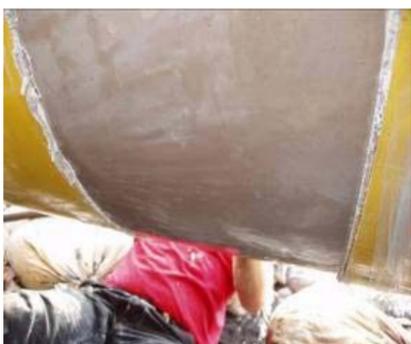
Cured filler compound (30 minutes) and is ready for Clock Spring coil installation.

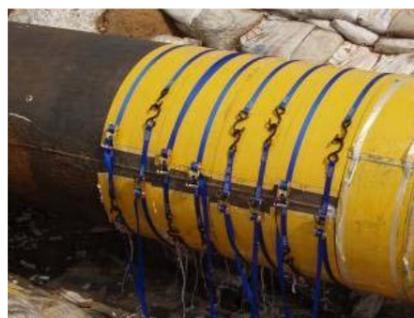
Filler is held with a 42" mold to ensure filler is equally distributed around the pipe and "fills" the corrosion pits.

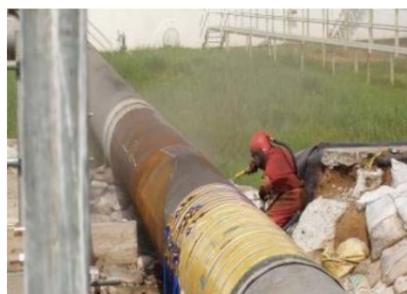
Sand-blasting crew on the pipe section.

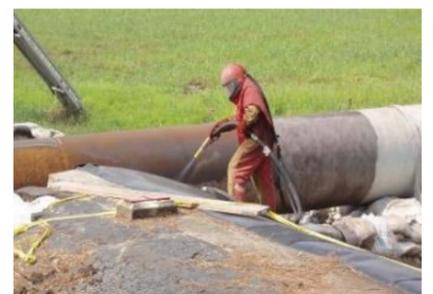
Sand-blasting of the remaining pipe section length.

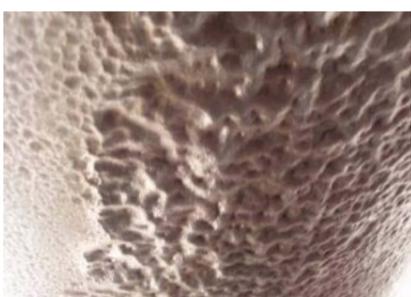
A 42-inch (1,067 mm) suction line at a storage terminal had sustained extensive pitting and corrosion – in some places, resulting in 80% metal loss – and needed immediate repair. The corrosion occurred in areas in which the pipe coating had not prevented moisture ingress. Where moisture was entrapped, there was considerable galvanic corrosion.

Extensive pitting and general corrosion.

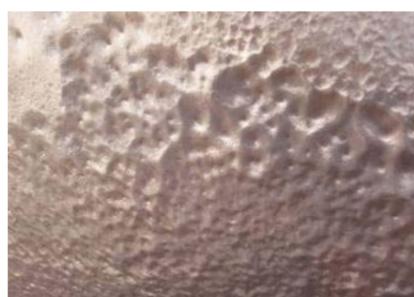
Extensive pitting and general corrosion.

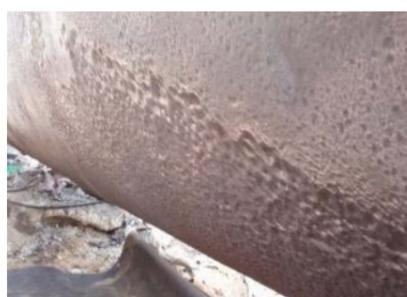
Extensive pitting and general corrosion.

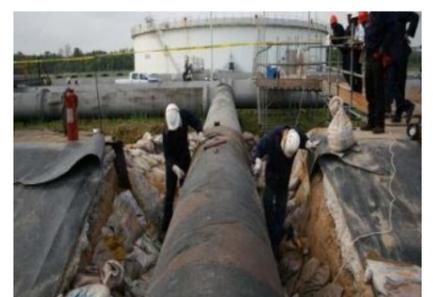
Section of the pipe cleaned to a NACE 3 standard.

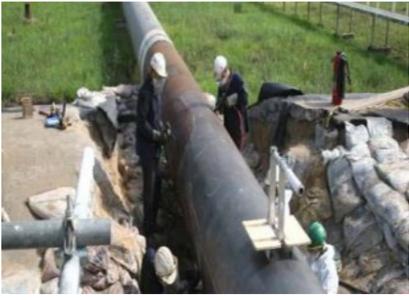
Two pneumatic descaling guns used in tandem with 3"x7" grinding machines fitted with wire wheels.

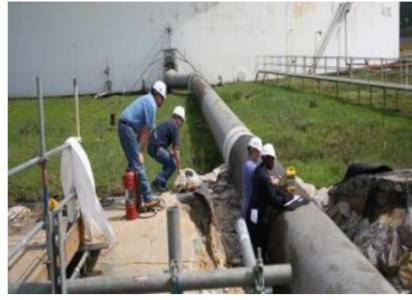
NDT inspection completed and prep surface for Clock Spring repair.

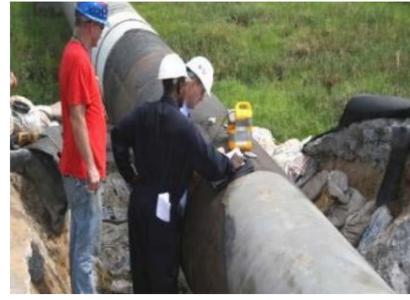
NDT inspection process taking place.

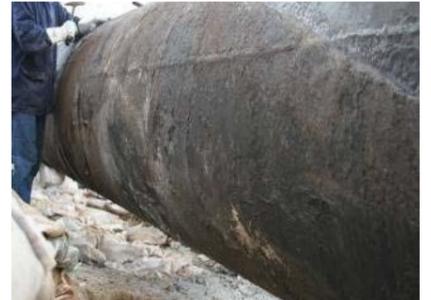
Gradually remove the scale and coating for NDT inspection.

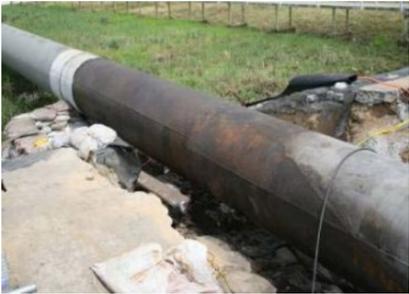
Cleaned pipe surface for NDT inspection.

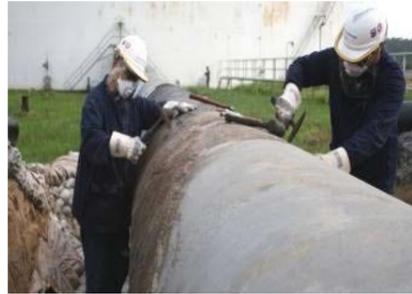
Corrosion scale manually removed using hand tools.

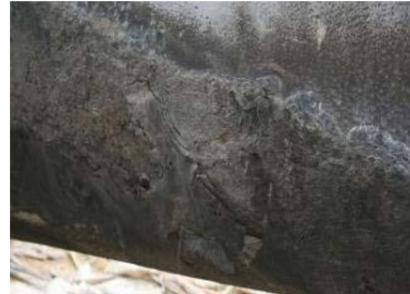
Second layer of corrosion scale needed to be removed.

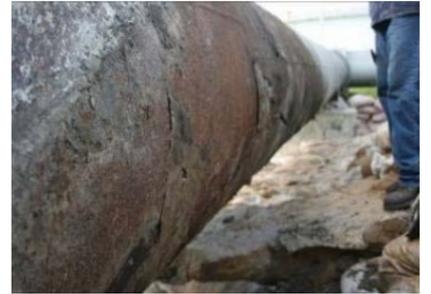
Corrosion area

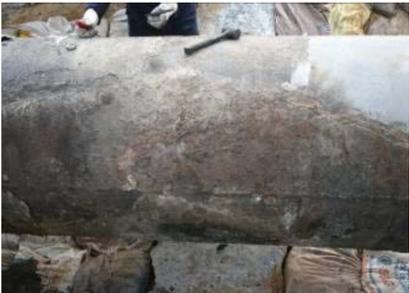
Unfortunately, extensive corrosion was not the only concern. When the pipe was excavated, large areas were coated with “coal tar,” which had to be removed carefully by hand, followed by the removal of an additional layer of corrosion underneath. This painstaking process was necessary to avoid further damage to the pipe.

Corrosion and condition of the "coal tar" coating on the pipe immediately after excavation.

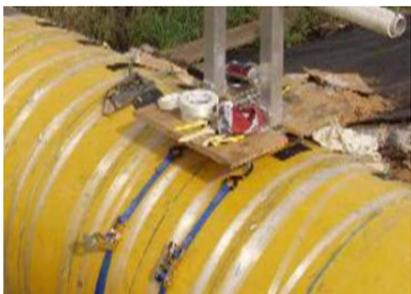
The coil tightened using the cinch bar to extrude excess filler and adhesive.

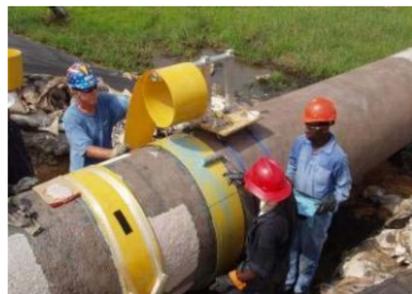
Installation of Clock Spring using the spool feed method.

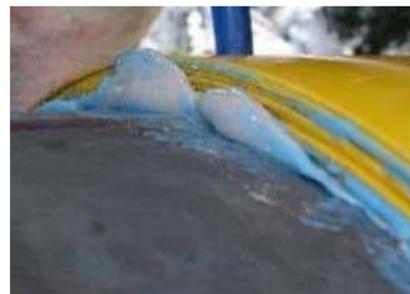
Adhesive exiting the side of Clock Spring coil from tightening.
