# Clock Spring Repairs Dent Due to Rockfall in Hydro-Electric Pipeline

### Pipe Details

- 914-mm (36-inch) diameter API 5L Grade X60  
70 Bar (1,015 psi) design pressure.
- 30 mm (1.18 inch) original wall thickness.
- Dent caused by ground movement.
- Access by 75-minute walk or by helicopter only

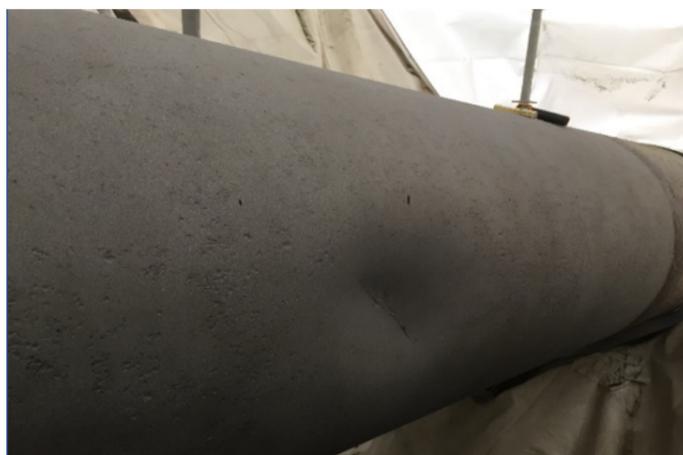
- Falling rock caused by a landslide in a remote area in the French Alps dented a 36-inch (914-mm) API 5L Grade X60 hydro-electric pipeline.
- Clock Spring mobilized a team and equipment to the site by helicopter.
- Clock Spring trained technicians filled the dent and applied four 36-inch (914-mm) Clock Spring composite sleeves to the damaged pipe.
- Repairs were executed in 2 days.
- The Clock Spring solution did not require disruption to service.

*Dent.*

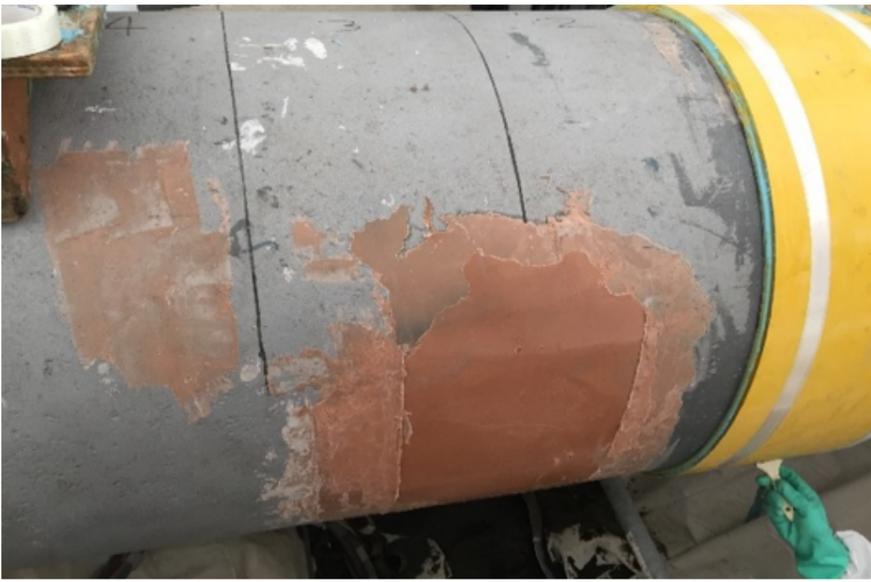
*Dent filled with MA441 filler material.*

Finding none, the team began the repair with two single wrap molds, using 23 packs of incompressible MA441 filler to fill the dent. With the circumferential ovality restored, installers applied four 36-inch (914-mm) Clock Spring composite sleeves over the course of 2 days.

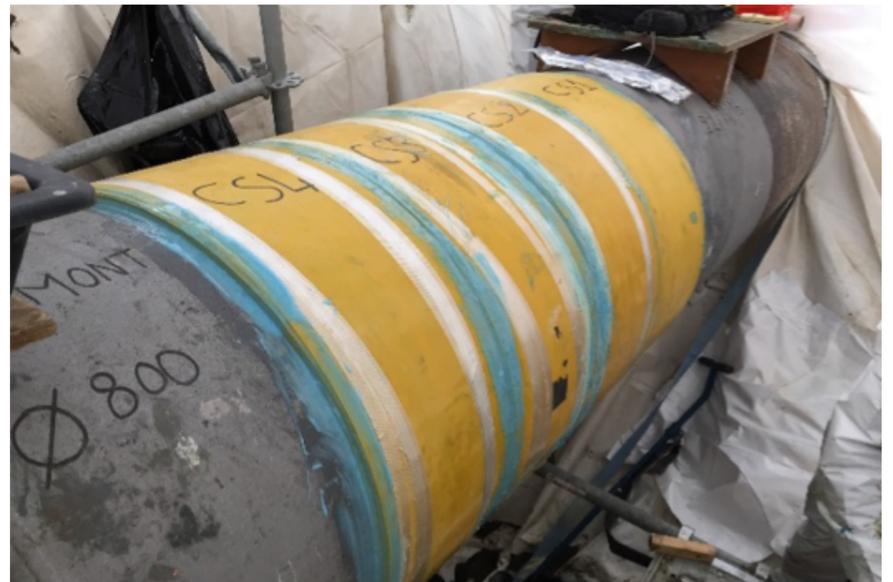
*Completed repair.*
