# Clock Spring Repairs Dent Under Water

### Pipe Details

- 6-inch (152-mm) pipeline had sustained dents less than 7%
- 12 feet (3.6 m) of water
- 14 feet (4 m) below the mud

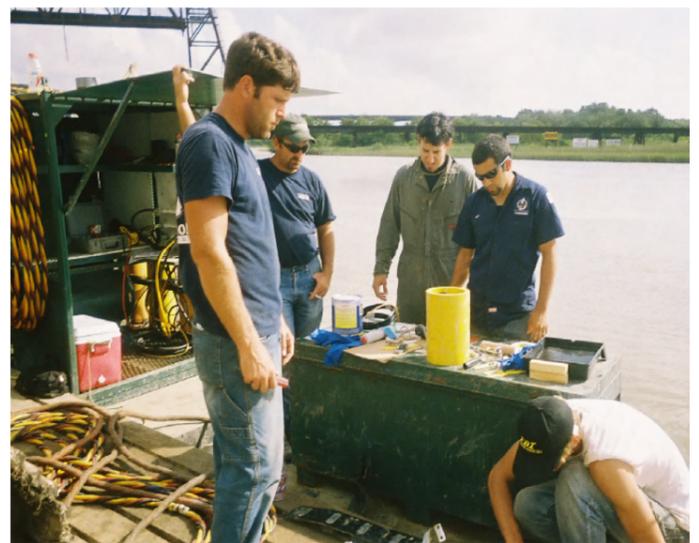
*Preparing the Clock Spring coil for underwater installation*

The installer applied a single 6-inch (152-mm) Clock Spring coil with special underwater adhesive to the damaged area of the pipe, completing the repair in a matter of minutes.

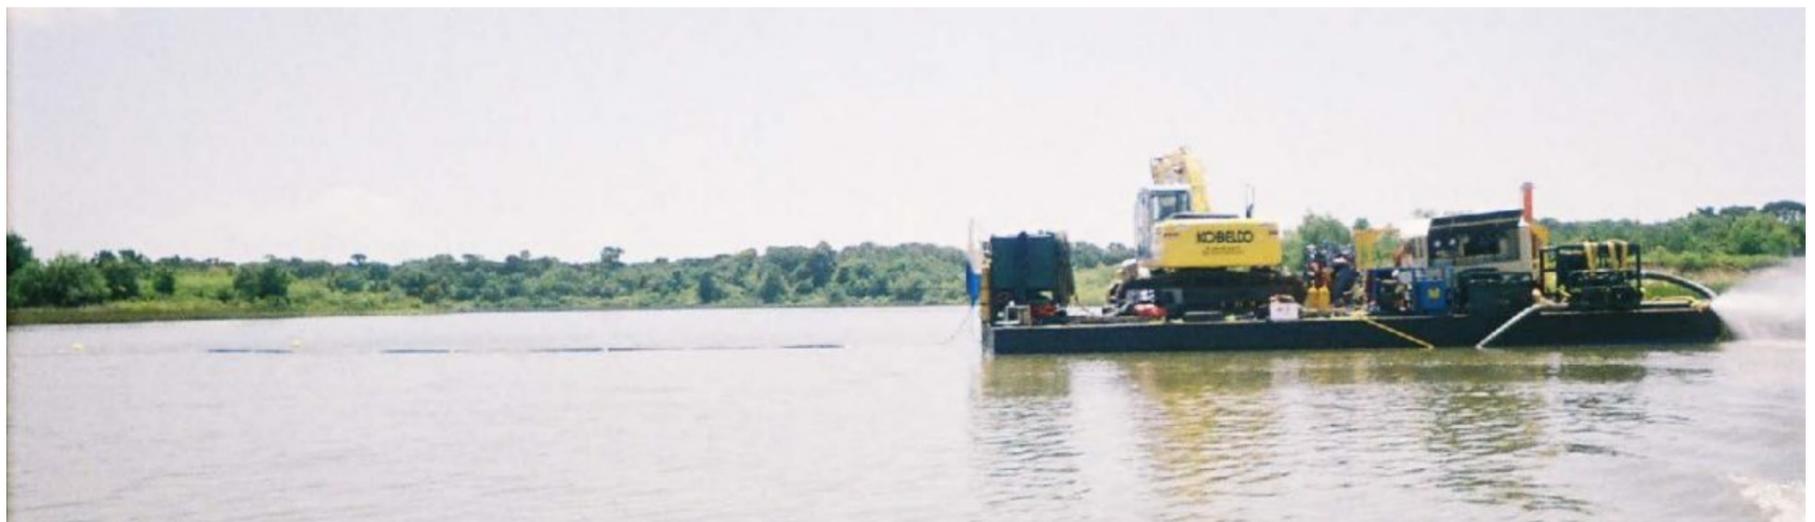
*Pipeline Crossing - Cedar Bayou*

The 6-inch (152-mm) pipeline located in 12 feet (3.6 m) of water 14 feet (4 m) below the mud line was dented, and the owner was concerned about potential environmental impact if the damaged line remained in use.

To get a clearer picture of the damage, divers removed the concrete coating surrounding the dented area and inspected the line for cracks. Their assessment allowed a determination that a Clock Spring coil would be a suitable repair option.

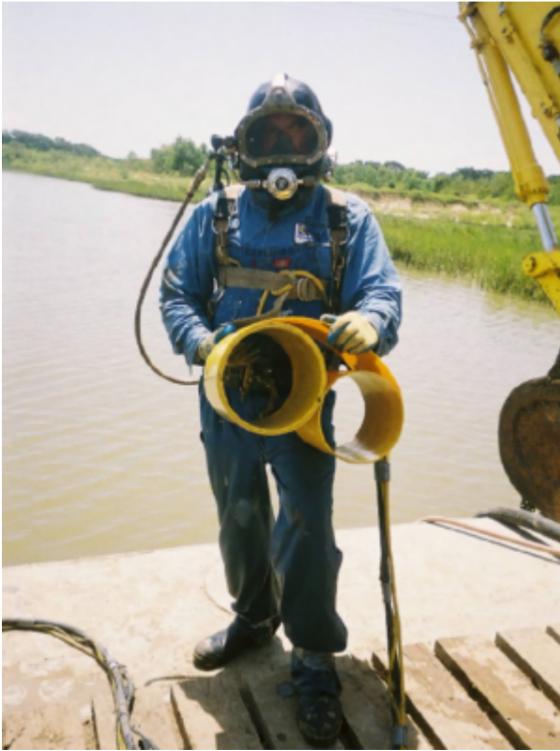
*Clock Spring diver*

A trained diver was able to perform the repair in a few minutes with the line in service, meeting all of the owner's requirements for safety, efficiency and environmental protection.
