# Clock Spring Restores Gouged Pipeline

United States

### Pipe Details

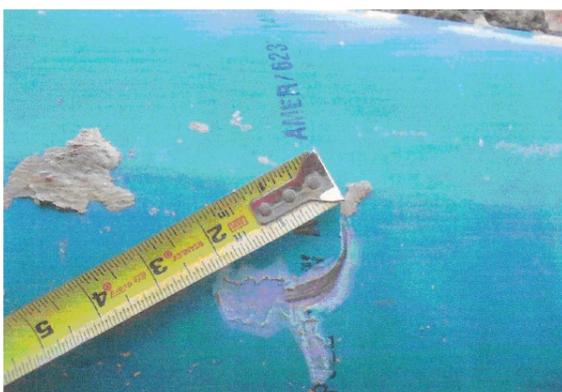
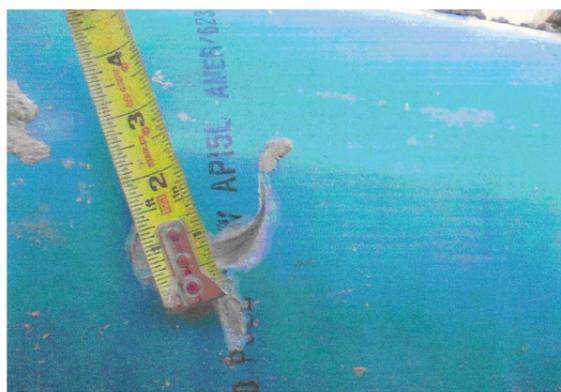
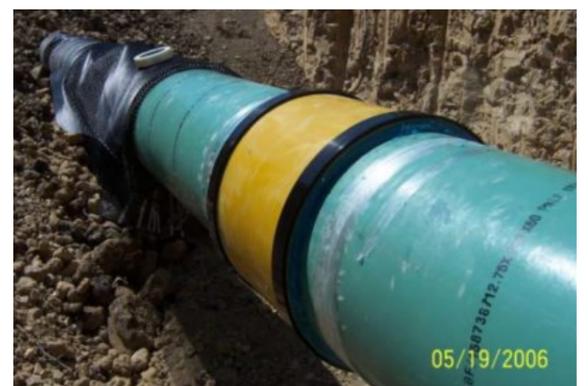
A 12-inch (305-mm) Grade API X-60 gas pipeline was gouged by a backhoe and required repair. The damaged area measured 1.5 inch by 1 inch (38 mm by 25 mm) and was 0.04 inch (1 mm) deep.

Conventional repairs are identifiable in the data collected by the magnetic flux leakage inspection tool, but traditional Clock Spring composite repairs could not be identified until a minor modification to the installation process rendered them visible to the tool.
