# Clock Spring Takes on Onshore Refinery Repair

Far East

- 12-inch (305-mm) diameter pipe

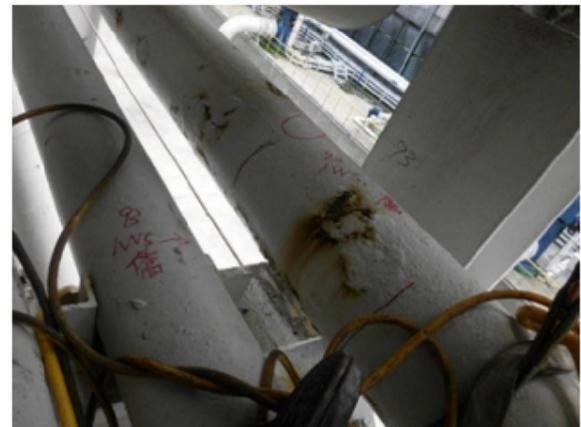
During one of these inspections along a gas rack, workers identified a 12-inch (305-mm) diameter pipe at a height of four stories that was exhibiting severe corrosion due to a combination of galvanic and crevice corrosion. This pipe needed reinforcement at every pipe support area for a length of 150 m (492 feet). A total of 20 pipe supports, each with a defect length ranging from 0.3 meters (1 foot) to 1.2 meters (4 feet), required repair.

*Corroded Pipe Support Area*

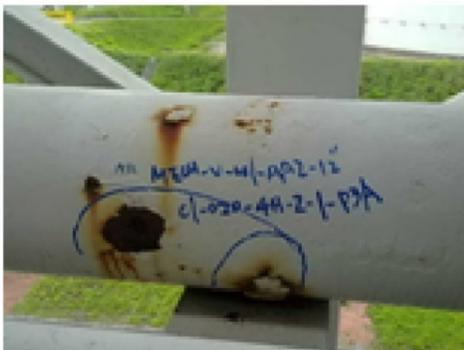
*Corroded piping's at gas rack*

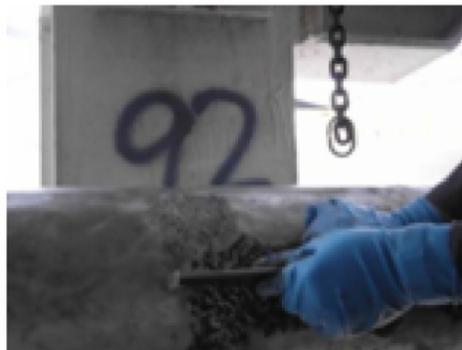
*Cleaning and measuring the defect area of the pipe*

A team of 10 trained technicians wearing safety harnesses cleaned and measured the defective area of the pipe and rebuilt the pipe surface to prepare it for the installation of the Clock Springs. The pipe was lifted off the pipe rack using chain blocks, and the installation began. More than 41 coils were used to repair the 20 corroded areas.

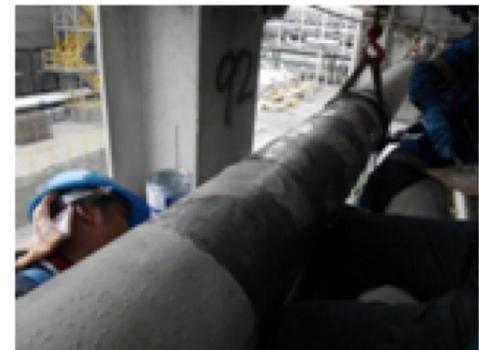
*Cleaning and rebuilding the surface of the pipe*

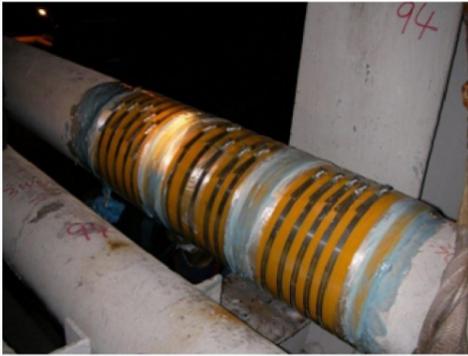
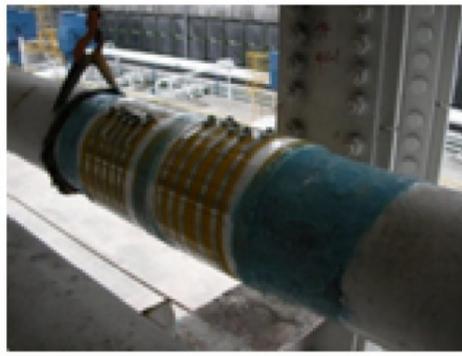
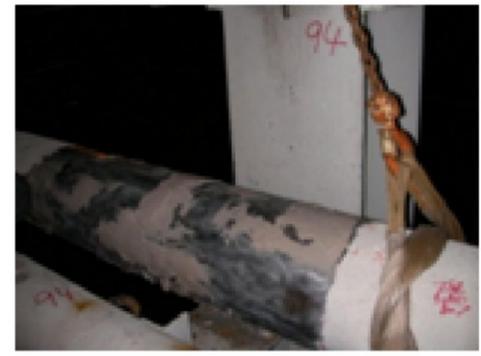
*Installation of Clock Spring*

*Repair During Night*

The entire repair was carried out over a single 14-hour shift overnight while the pipe remained in operation.
