Composite Contends with Arctic Conditions in Underwater Pipeline Repair

Cook Inlet, Alaska, USA

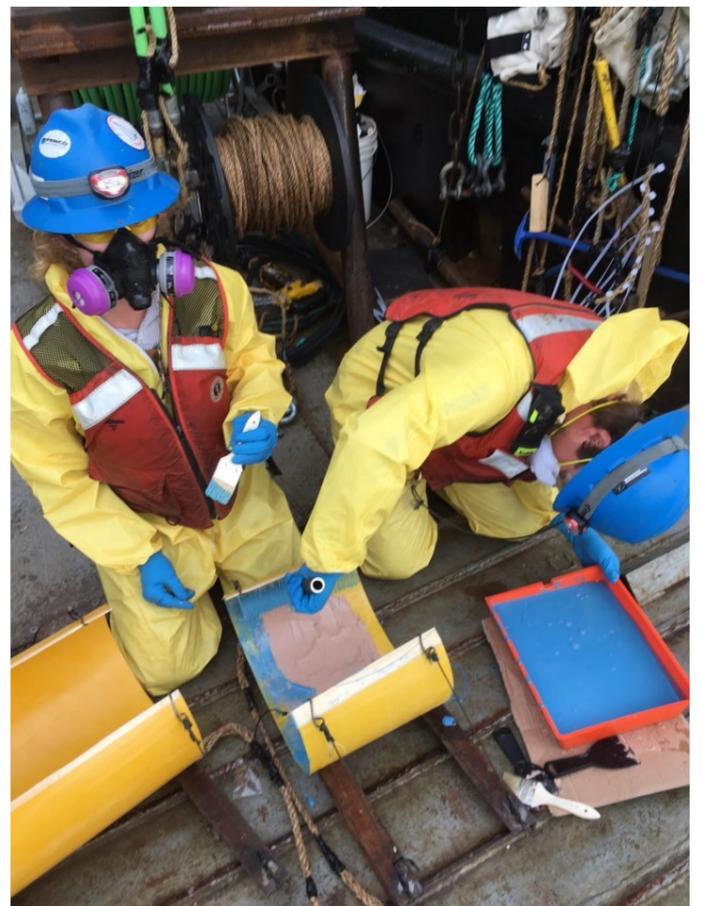
Team members on the barge apply filler and adhesive to the Snap Wrap repair sleeves in preparation for underwater installation.

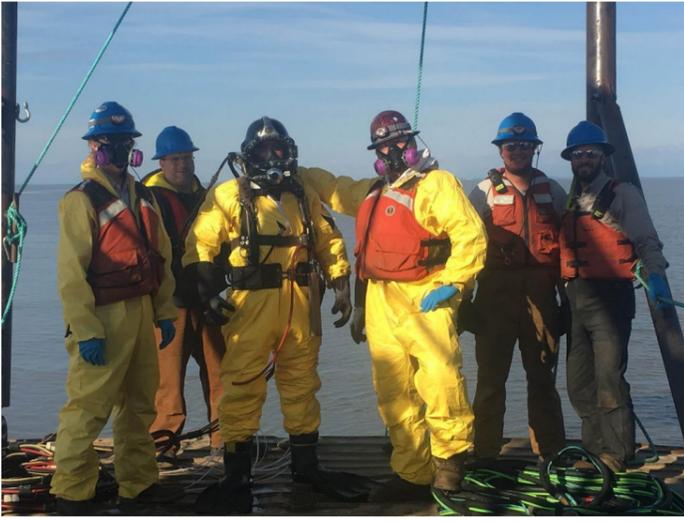
The diver prepares to begin the day's dives to install Snap Wrap repair sleeves on a 10-inch (254- mm) underwater gas pipeline.

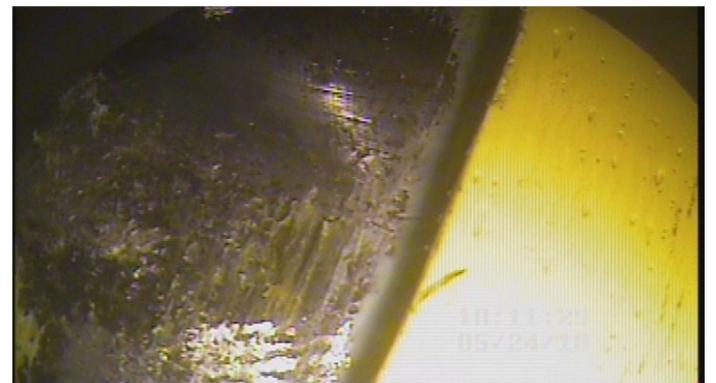
An inspection camera shows the completed Snap Wrap repair.

Following this work program, the diver repaired all the damaged girth welds and restored the line to safe working order. This solution proves the applicability of composite solutions in water in cold conditions and illustrates the adaptability of the technology.
