# Composite Restores Wind Tower Flare Line Integrity

Czech Republic

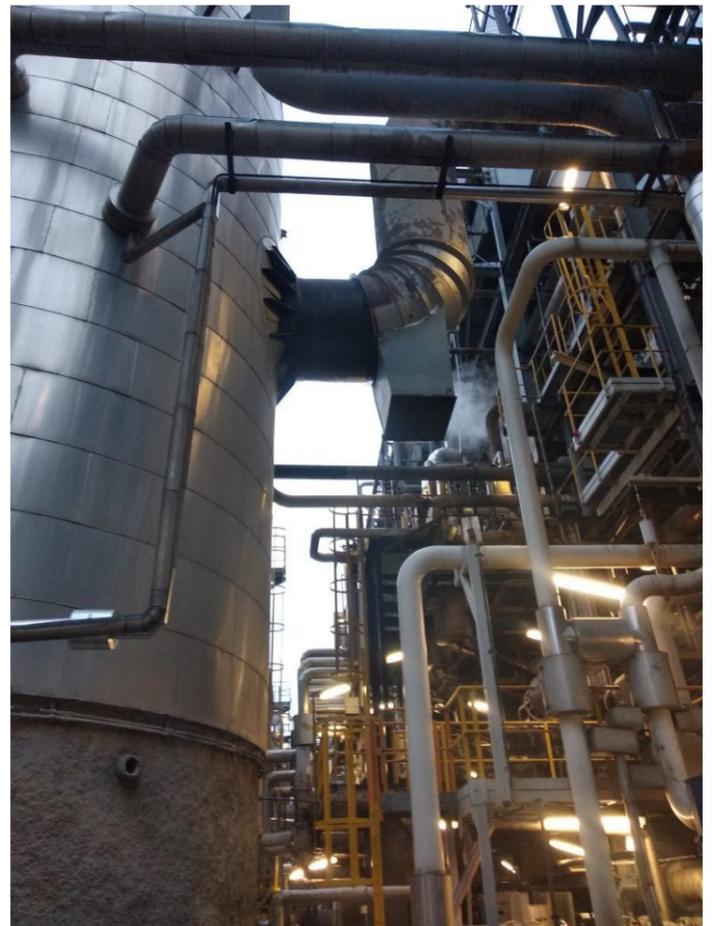
*The elevation of the line made it difficult to access the damaged pipe, which complicated the repair.*

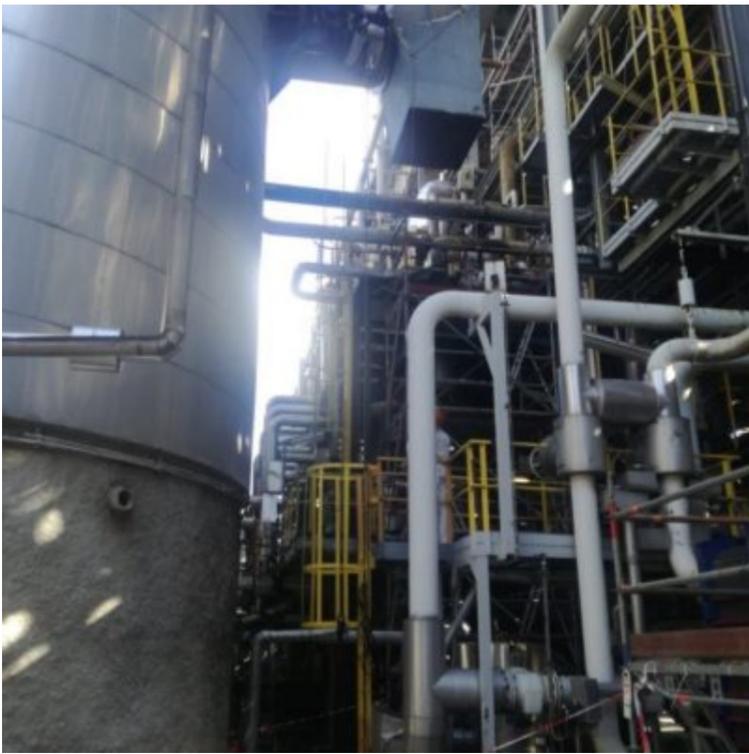
Using ropes to access the flare line, Clock Spring experts assessed the damage and suggested carbon fiber DiamondWrap® with HTA (High Temperature Ambient) epoxy for the repair. The DiamondWrap® system includes a bidirectional weave of carbon fiber and a 100% solids epoxy that form a composite system stronger than steel. Its low profile enables installation in confined spaces and on irregular surfaces.

*Workers use rope access to inspect the pipe.*

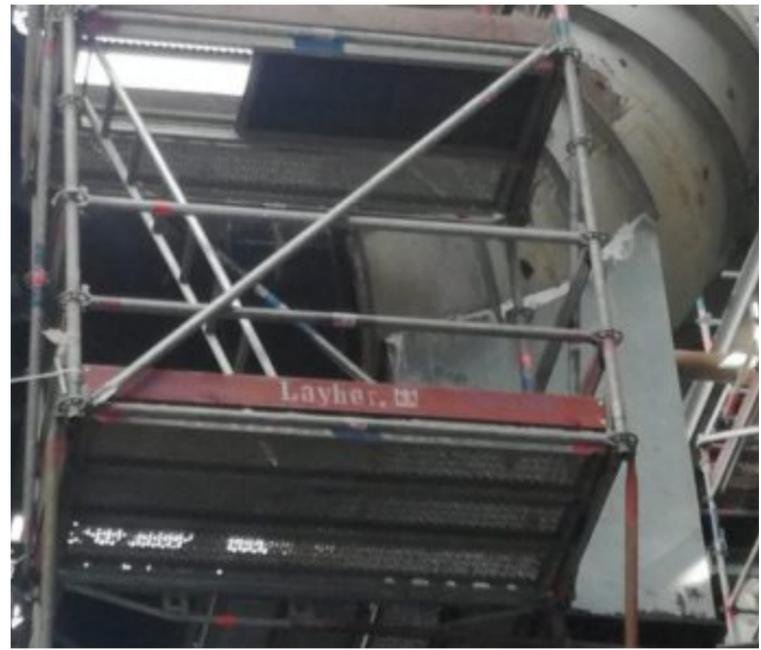
*Because of the location of the line, special scaffolding was built to give technicians access so they could wrap 508-mm (20-inch) wide swathes of fiber carbon cloth around the 2,000-mm (78.7-inch) diameter flare line.*

When the preparatory work was completed, a team of 3 technicians reached the repair area using rope access and restored the integrity of the damaged pipe. The team undertook the challenge of wrapping 508-mm (20-inch) wide swathes of fiber carbon cloth around the 2,000-mm (78.7-inch) diameter flare line and was able to complete the installation in 5 hours from sandblasting to final placement of the composite wrap.

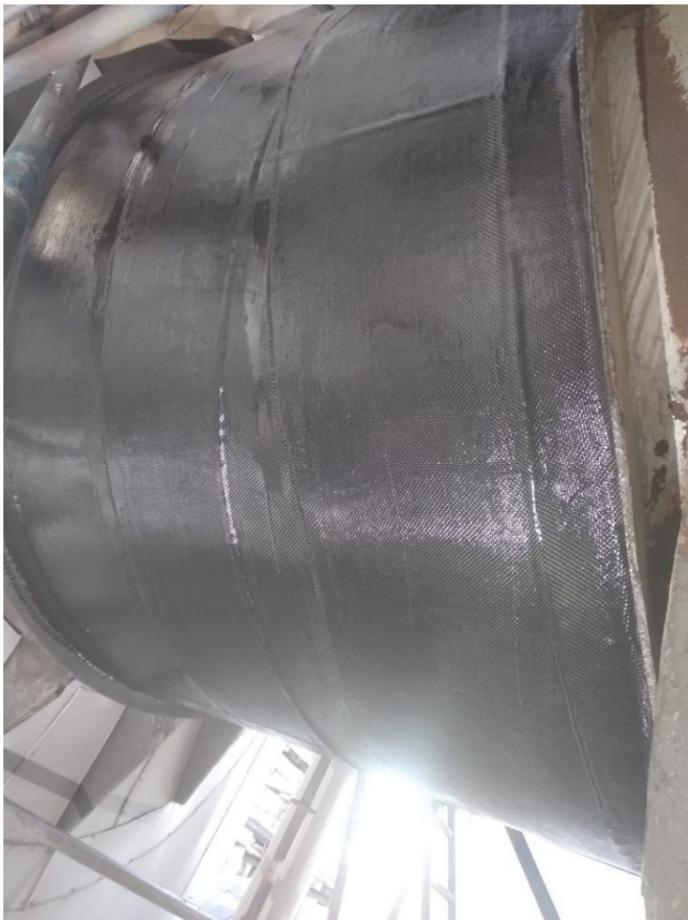
*Installers completed the repair within 4 working days of the initial inquiry without introducing negative environmental risks or hot work and without disrupting refinery operations, providing a solution that delivers an additional 2 years of safe service.*

Installers completed the repair within 4 working days of the initial inquiry without introducing negative environmental risks or hot work and without disrupting refinery operations.
