Composite Solution Permanently Reinforces Seam Weld Anomaly on 16" Ethylene Line

Louisiana

Pipe Details

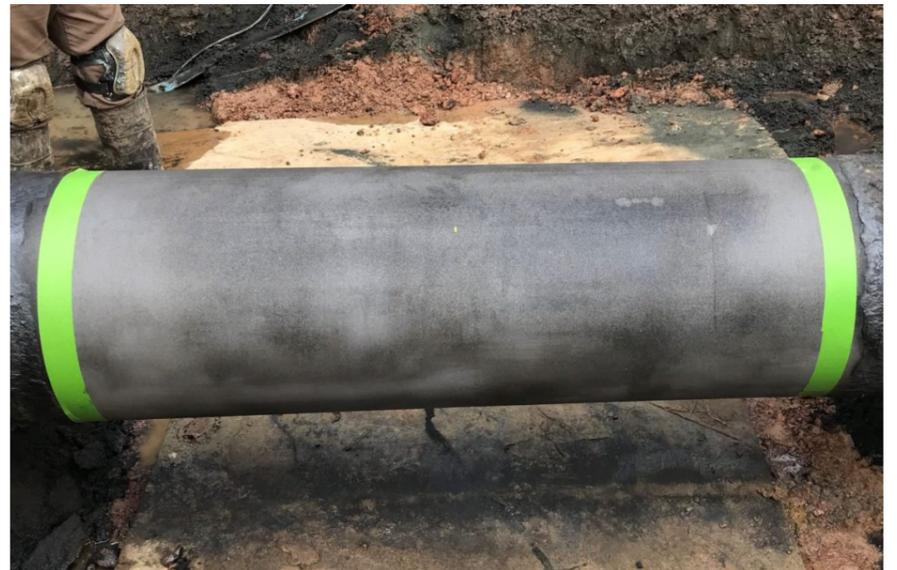
- A 16-inch (406.4 mm) pipeline carrying liquid ethylene had a seam weld anomaly
- The damaged area was 2.3 inches (58.4 mm) long, 0.001 inch (0.025 mm) wide and 0.064 inch (1.63 mm) deep
- The repair area was 3 ft (1 m) long
- 1,336 psi Maximum Operating Pressure (MOP)
- Ambient Temperature 75°F (24°C)
- Pipeline Temperature 66°F (19°C)

Two CSNRI supervisors and a team of installers from a local contractor mobilized to the site to carry out this seam weld repair. The trained and certified technicians cleaned the damaged section of pipe to remove the pipe coating before using a bristle blaster to achieve a surface profile equivalent to SA2.5. They wiped the prepared pipe with acetone and applied special filler material to tented/voided areas. Next, the entire repair zone was coated with a special epoxy coating. With these materials installed, technicians placed a fiberglass isolation layer with magnetic markers over the pipe so the repair area can be detected by an intelligent pig during inline inspections when the line is reburied.
