Composite Solution Reinforces LF-ERW Seam Anomaly on Ethylene Line

Louisiana

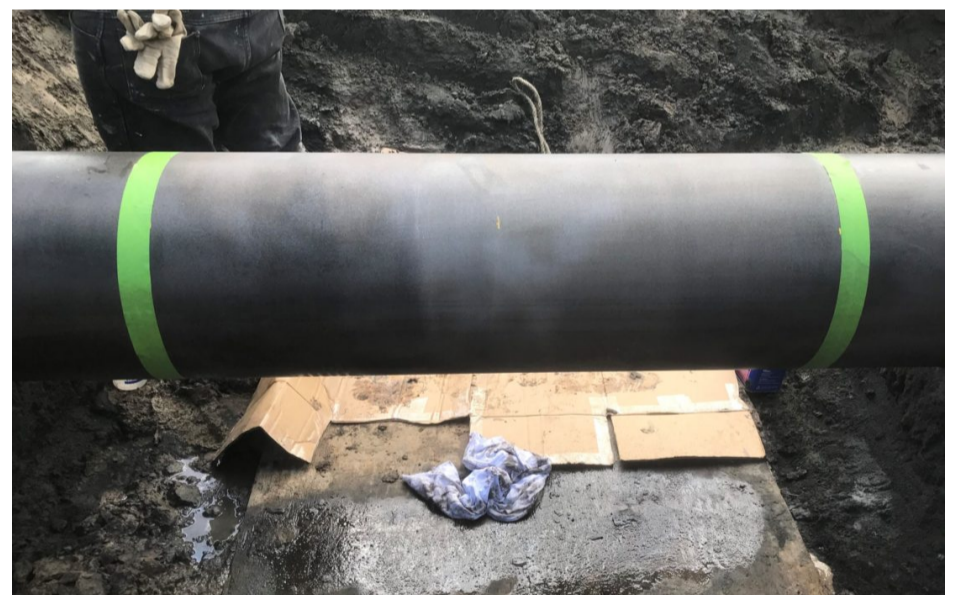
Technicians prepared the pipe surface to a near-white profile and wiped it with acetone in preparation for the composite installation.

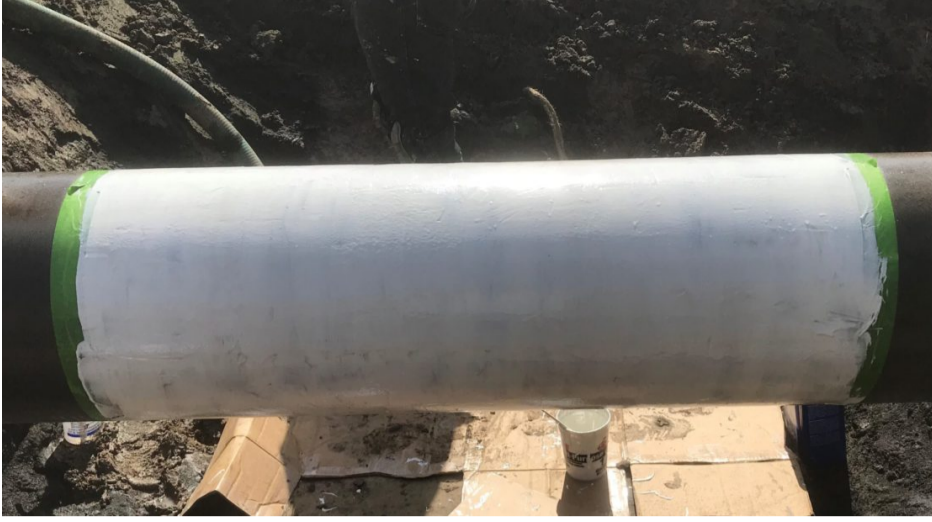
Installers applied a special two-part epoxy coating to the repair zone.

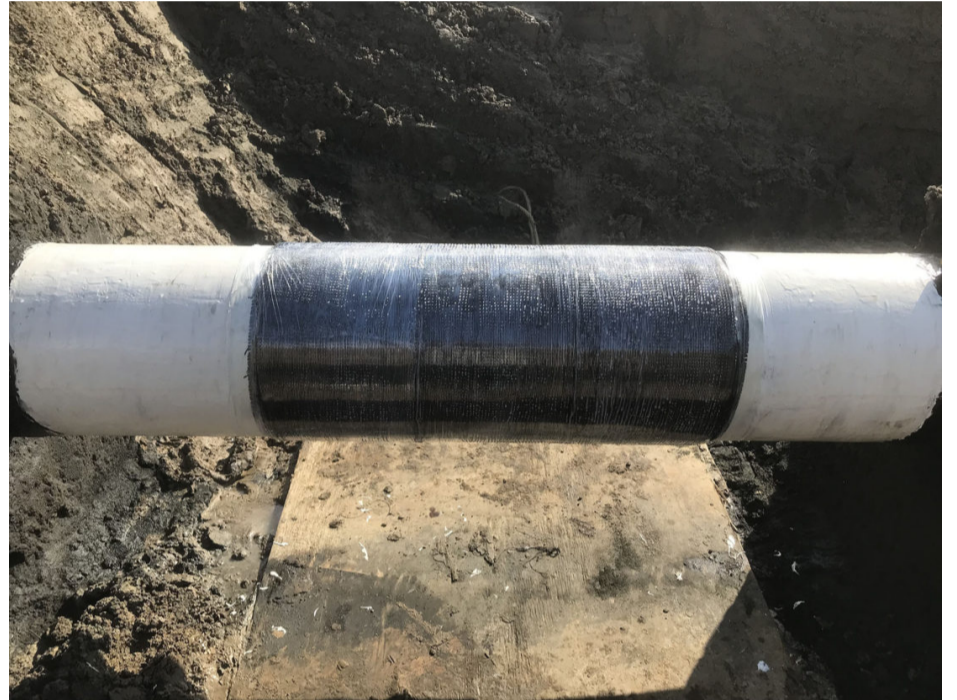
The team installed 24 layers of composite cloth over a 3-ft (1-m) section of pipeline, then covered the repair area with constrictor wrap and perforated it to allow the composite to cure.
