Composite Solution Replaces Damaged Casing Spacers

United States

Summary

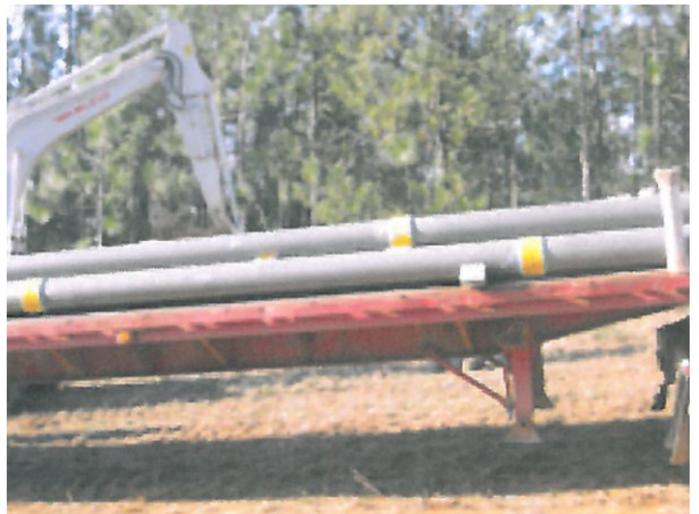
Clock Springs pre-installed on pipe sections

In advance of the new pipeline installation, the team installed 57 Clock Spring units, spaced 12 feet (~3.7 m) apart on the new pipe sections. This work was executed in a span of eight hours.

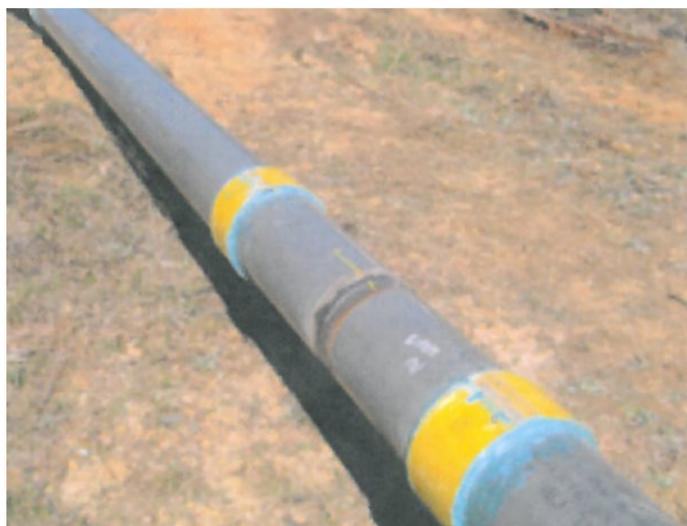
Casing Spacers at girth weld joint

To address the problem, the team cut the Clock Spring composite repair sleeve to 5.5-inch (~14 cm) widths and applied the product as casing spacers to provide protection for the girth welds and pipeline during installation.

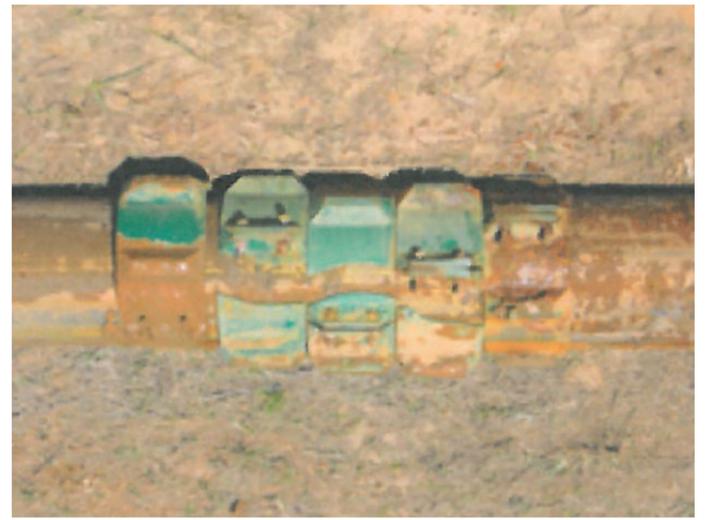
The existing pipeline was cut and pulled through the casing for removal. When the team inspected the pipe, they found that nearly all the existing casing spacers were broken, and there was significant corrosion at the bolts. Many of the spacers were so damaged that they failed to hold during pipe removal.

Spacers from old pipe, failed to stay in place when pipe removed, with corrosion
