Composite Solution Restores Pipeline Explosion Damage

Bahrain

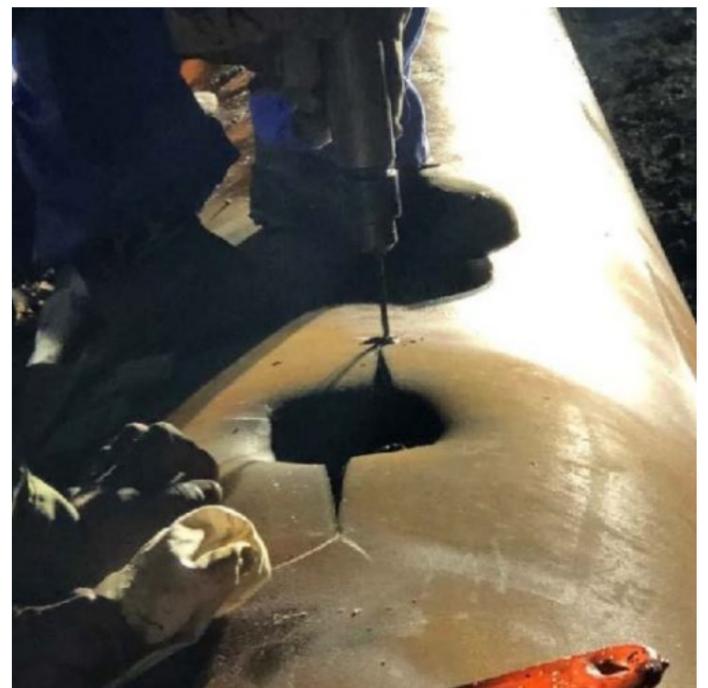
The explosion had created a 343 mm by 114 mm (13.5 by 4.5 inch) hole in a 711-mm (28-inch) carbon steel pipeline that was transporting crude oil under 10 bar (145 psi) pressure, and the wall of the pipe was bent inward in an irregular shape. This pipe was crucial to operations because it was the only pipeline delivering crude to the refinery. Without this line, the refinery would have had to completely stop production.

The installation team prepares to plug the hole in the pipeline. (Photo courtesy of ClockSpring|NRI)

As soon as the composite system was designed, MCSC WLL dispatched a team of 12 trained technicians to the refinery. Crude flow through the line was stopped while the team plugged the hole and began preparing the surface of the pipe for the composite repair, which was carried out with about 50% of the crude oil remaining in the line.

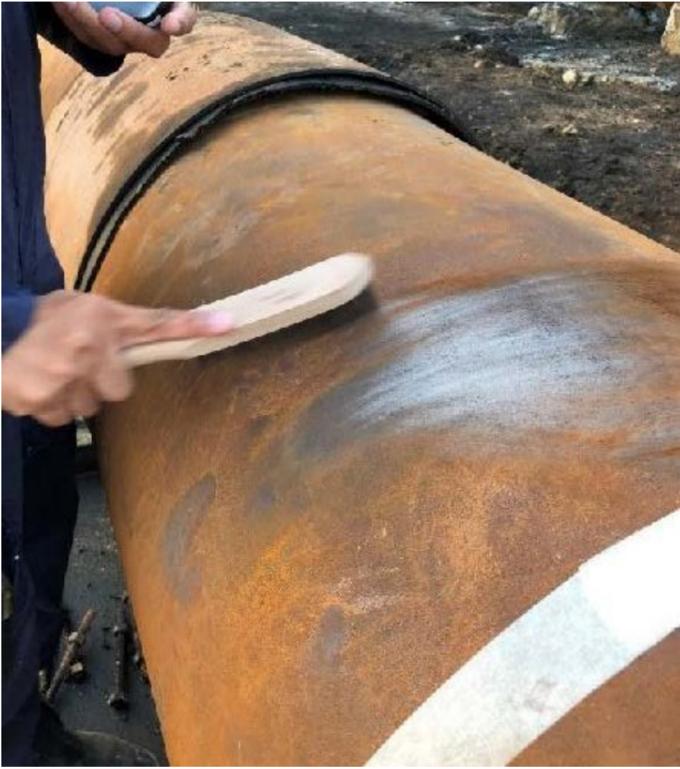
The installation team prepares to cover the damaged pipeline. (Photo courtesy of ClockSpring|NRI)

The repair designed for the pipeline was a DiamondWrap® system, which is made with a bidirectional weave of carbon fiber and a 100% solids epoxy that form a composite system that is stronger than steel. The structural system forms a pipe around a pipe, and each successive wrap increases the pressure rating. The bidirectional weave of the carbon fiber provides strength in both the hoop and axial directions, a design that practically eliminates creep, ensuring that there is no reduction in strength over time. This application was on a straight run of pipe, but because of its low profile, DiamondWrap® can be installed on tees and elbows and is ideal for confined spaces and irregular surfaces that require structural reinforcement or leak containment.

Technicians installed 26 layers of DiamondWrap® over a 3-meter (9.8-ft) length of pipe. Working continuously, the team was able to complete the repair in 16 hours, working through the night to finish the installation as quickly as possible to restore the line integrity so refinery operations could recommence.
