# Composite Solution Seals Crack in Gas Transmission Line

Czech Republic

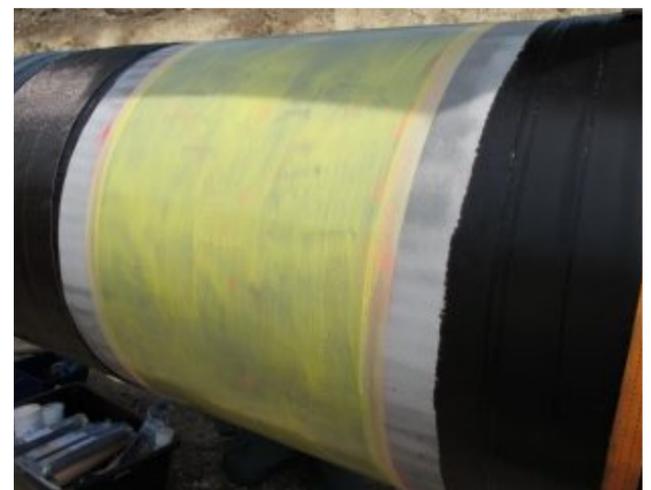
*The prepared section of pipe is ready for the fiber wrap*

Following normal installation procedures, the team uncovered the pipe and sandblasted the surface to prepare it for the repair. After applying filler and primer, the technicians applied the carbon fiber material to the damaged line.

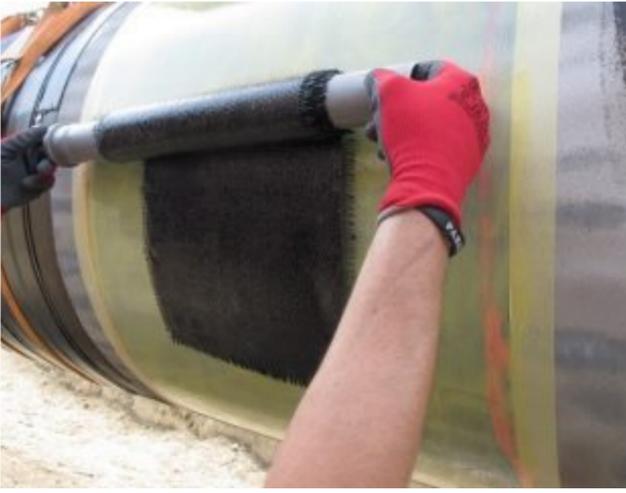
A gas transmission line operator discovered a 25-mm (0.98-inch) longitudinal crack on a bend section of a 900-mm (35.4-inch) diameter carbon steel pipeline that was under considerable loading. The crack had penetrated 80% of the wall thickness and posed a significant safety threat.

*A Clock Spring trained and certified repair technician from SEPS applies DiamondWrap® to the damaged pipe.*

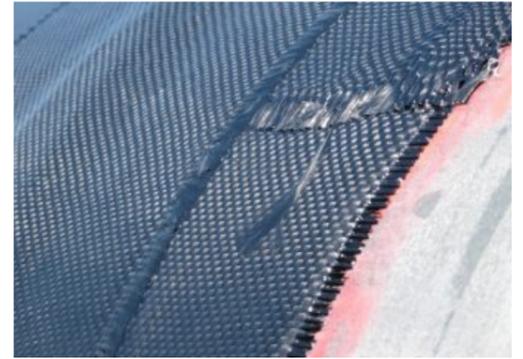
*Each successive layer of DiamondWrap® increases the pressure rating.*
