# Composites Enable Underwater Line Repair

Peru

### Pipe Details

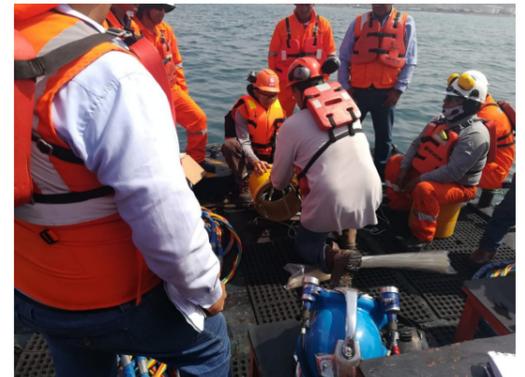
*The installation team reviewed procedures before the dive. (Photo courtesy of Morken Peru SAC)*

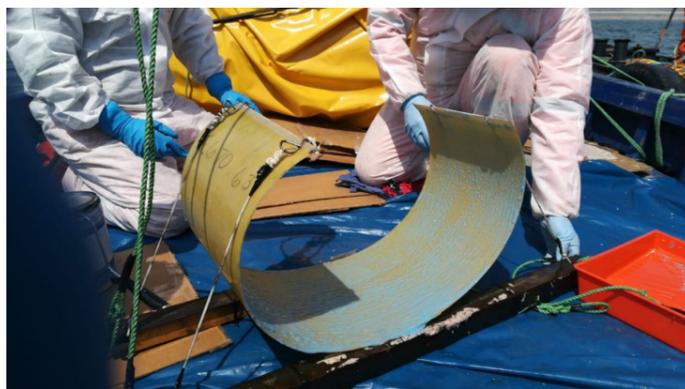
*Technicians on the boat prepared each sleeve on a special frame designed to simplify placement by the diver. (Photo courtesy of Morken Peru SAC)*

proprietary filler material, which was used to fill each dent and then covered by a single wrap mold. Once the dents were filled and covered, the team on the boat prepared the first Snap Wrap sleeve for placement, applying the adhesive to a sleeve placed on a frame that would facilitate placement under water.

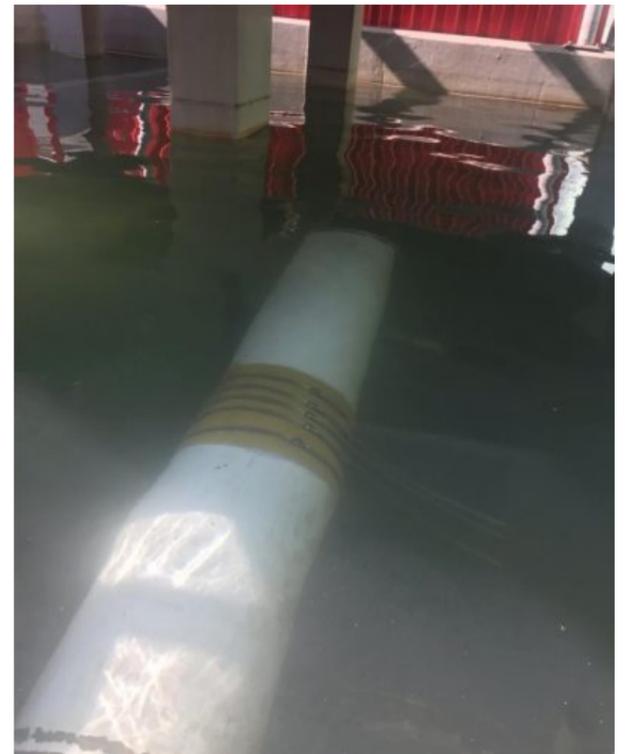
*Working with trusted partners, the company repaired the damaged lines within a week, avoiding the cost of cutting and replacing sections of the pipeline and achieving a regional "first" underwater composite repair. (Photo courtesy of Morken Peru SAC)*

A certified local diver entered the water with each prepared sleeve and placed it on the damaged pipe, installing a 4-layer Snap Wrap repair, adjusting the sleeves for optimal placement using metal hose clamps and plastic zip ties. Following this approach, the team was able to complete each repair in approximately 2 hours, with a final cure delivered in 2.5 hours. The entire repair program was executed in just a few days.
