Composites Extend Service Life of Corroded Flare Line

Bahrain

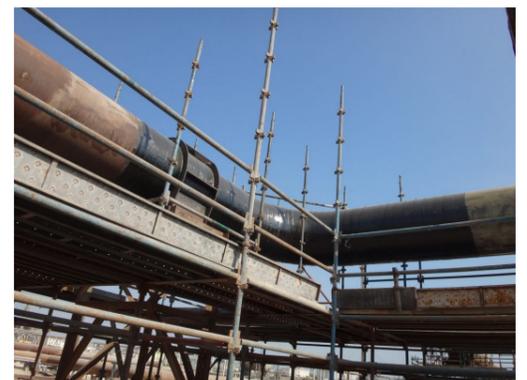
A team of 24 trained and certified installers worked from scaffolding erected around the elevated line to execute the repair. (Photo courtesy of ClockSpring|NRI)

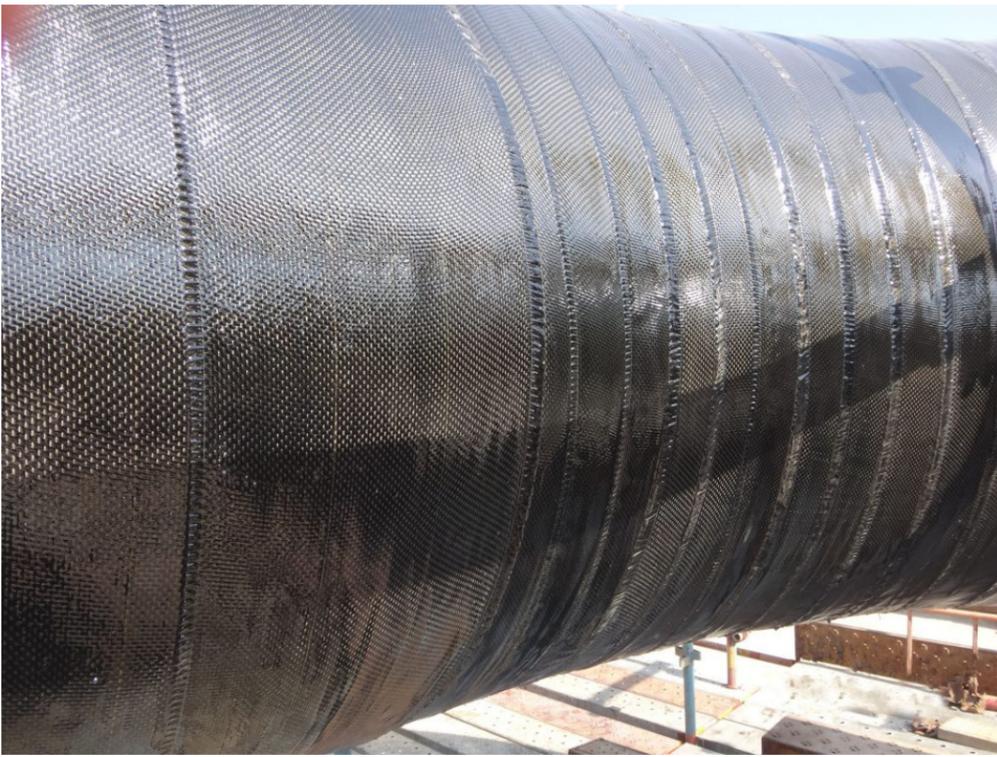
A closeup of the repaired line shows how the carbon fiber was wrapped around the line. The repair team covered the surface of the damaged area with two layers of carbon fiber affixed with HTA epoxy. (Photo courtesy of ClockSpring|NRI)

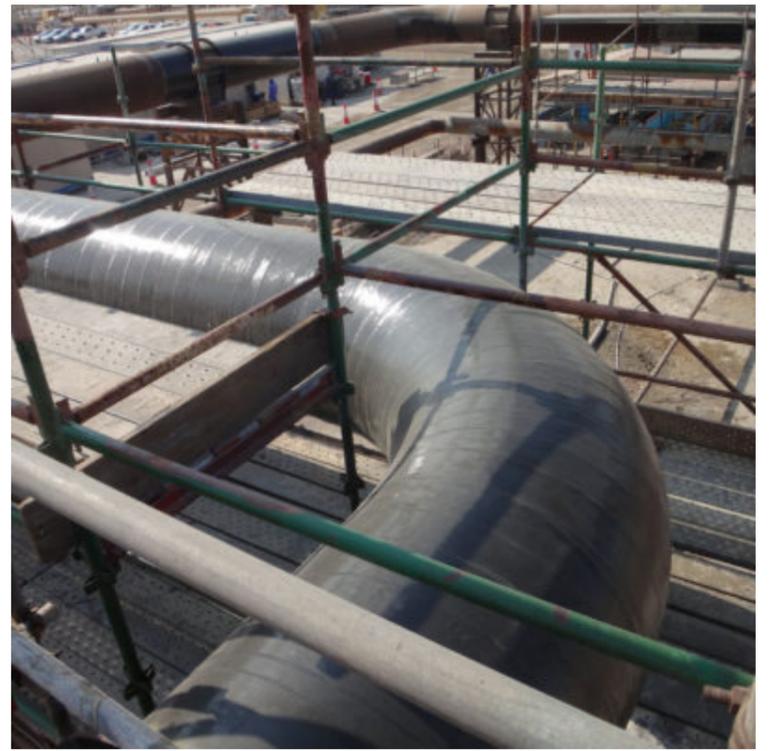
Despite being installed in a very hot environment where temperatures exceeded 45° C (113° F), the composite system cured perfectly, restoring the line to safe operations without introducing hot work and with no negative environmental consequences. (Photo courtesy of ClockSpring|NRI)
