Composites Restore Offshore Riser Integrity

Malaysia

Pipe Details

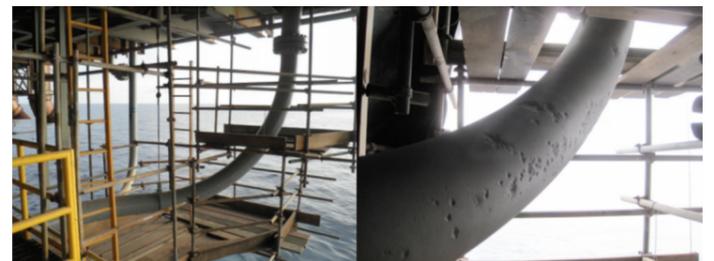
In examining the risers on an offshore production facility, an operator offshore Malaysia identified extensive pitting in a 305-mm (12-inch) riser with back-to-back bends. In some portions of the pipe, pitting had resulted in 60% wall loss. The company addressed this problem with a composite repair.

Riser with localized pitting

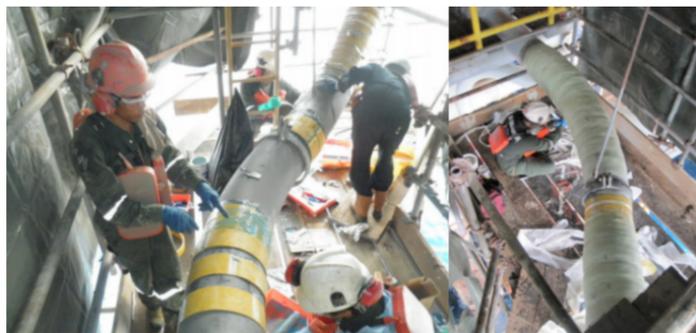
Installation of Snap Wrap & Contour

A team of Clock Spring specially trained local experts cleaned the riser, grit-blasting it an SA 2.5 surface preparation, removing rust, coating, and mill scale to produce a near-white surface prior to the application of the Clock Spring repair. The defects were identified and marked so they could be appropriately treated. The defects, which were concentrated at the bends, were first repaired with 76-mm (3-inch) wide Snap Wrap strips along a 1.8-m (6-foot) length of pipe.

In cases like this, where Snap Wrap applied around pipe bends is placed with spacing that exceeds 13 mm (0.5 in), the repair is overlaid by a Clock Spring Contour system.

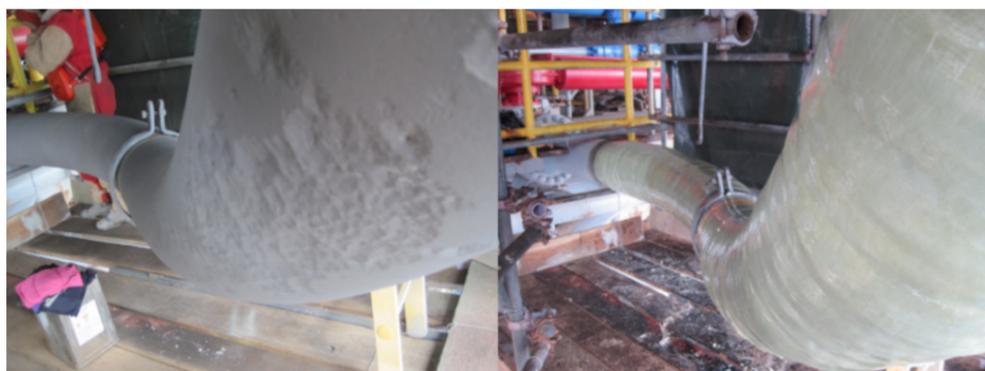
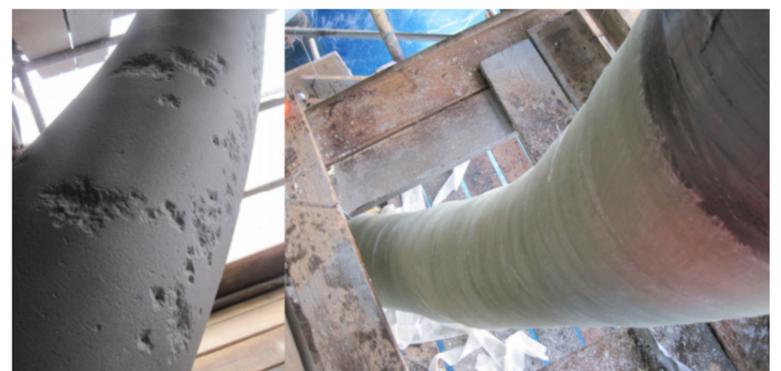
Riser repair: Before and after Contour installation

In this application, Contour overwrapped the entire 5-m (16.4-foot) length of the repair to create a solid covering. This hybrid system of prefabricated sleeves and in-the-field cured composite repair merges a robust structural laminate with a flexible protective outer composite

jacket. The repair is designed to last for two decades.

The Clock Spring Contour repair was performed in a day and a half of on-site work without taking the riser out of service.
