# Contour Achieves Pressure Containment, Reinforcement on 6-inch Kickback Line

Saudi Arabi

- 6-inch (152-mm) diameter
- Ethylene
- 148° C (298° F) operating temperature

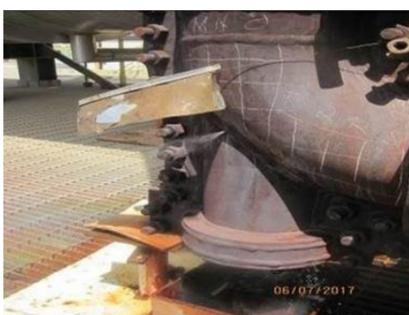
*Before: Pin Hole leak over Elbow Clamp and Low Thickness*

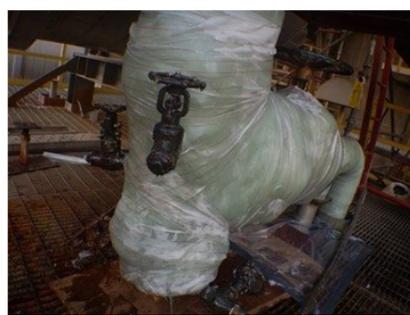
*After: Pinhole Leak Arrested and Entire Elbow Clamp Completely Wrapped*

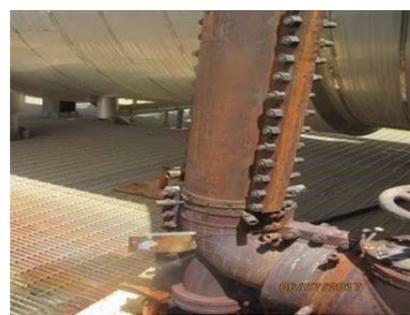
*Before: Vertical Straight Clamp With Low Thickness*

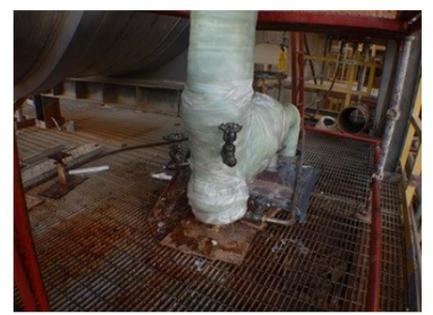
*After: Vertical Straight Clamp covered by Wrapping*

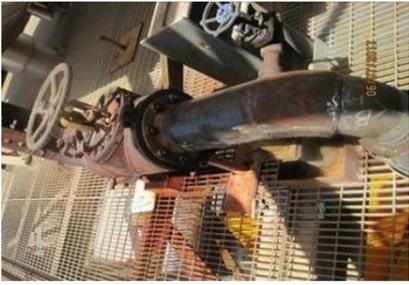
*Before: Patches and Low Thickness over Elbow and Piping*

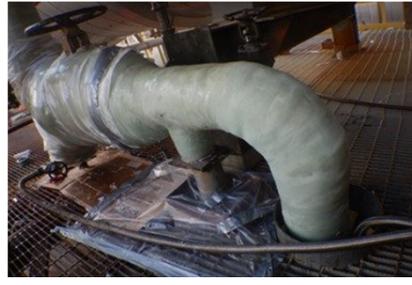
*After: Entire Low thickness Piping with Elbows Covered by Wrapping*

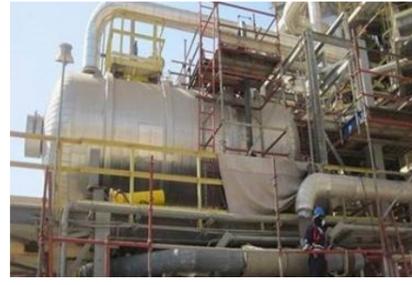
*Before: Over View of Entire 6" Kick Back Line With Low Thickness*

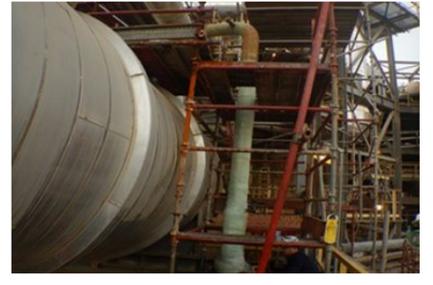
*After: Over View of Wrapping Over Entire 6" Kick Back Line to cover leaks and low thickness*

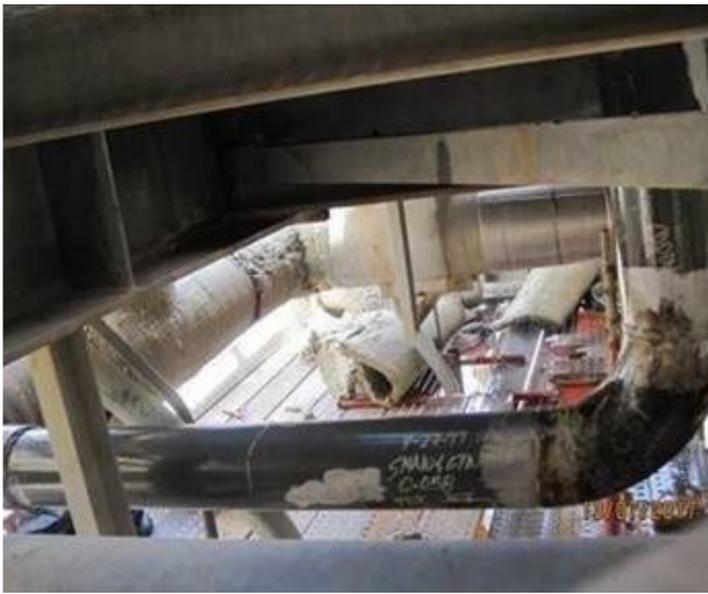
*Before: Low thickness over Elbow and Piping below Platform*

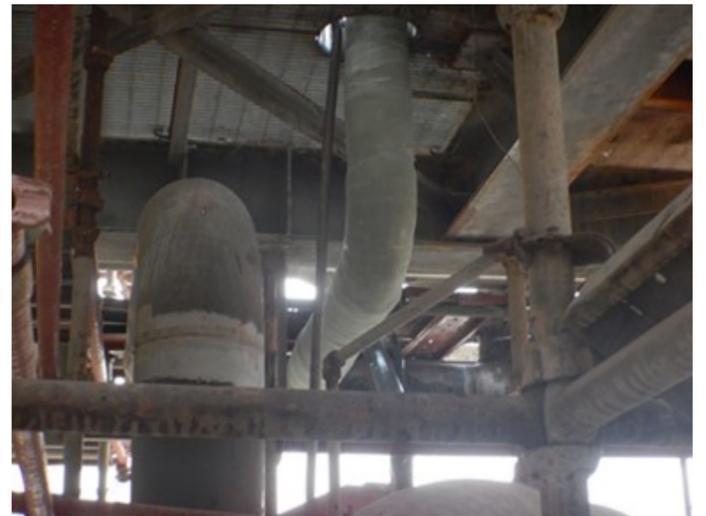
*After: Low Thickness Elbow and Piping below Platform covered by Wrapping*
