Contour Addresses Internal Erosion on Offshore Production Unit

West Africa

Pipe Details

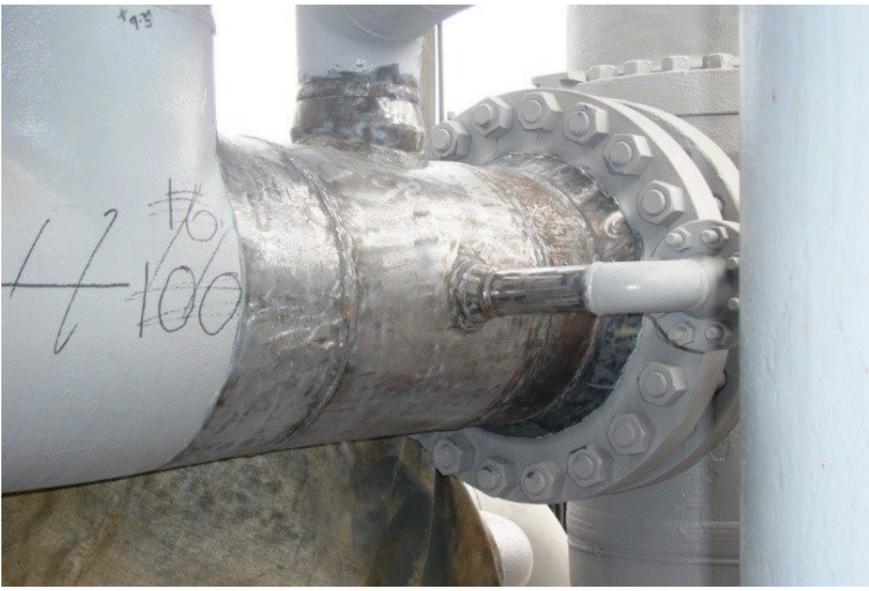
NDT inspection revealed several severe internal defects in a 406-mm (16-inch) line running into the main high-pressure separator on an offshore production facility. The erosion was significant, affecting multiple places along the pipe and growing at such a rate that imminent failure was likely. If the damage were to reach a critical point, the platform would have to be shut in, resulting in a huge loss of production. In addition to the financial impact, there was potential for considerable environmental impact in the event the eroded pipe developed a leak.

Internal Erosion Completed Repair
