Contour Corrects Internal Erosion Defect Offshore

West Africa

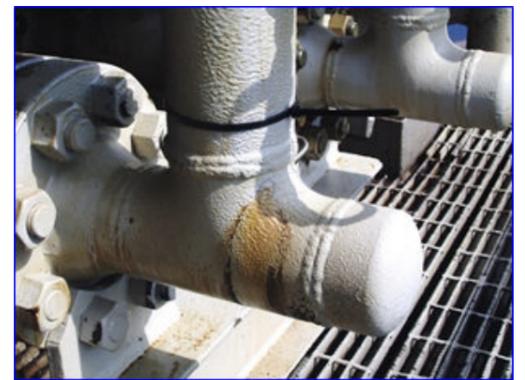
Internal erosion on a 102-mm (4-in) diameter cushion T on an offshore facility had resulted in a through-wall defect that required immediate attention to minimize environmental impact and return the line to service. The asset owner shut in production to isolate the line but was unable to address the defect using traditional repair methods to restore the line to safety.

Internal erosion on a 102-mm (4-in) diameter cushion T on an offshore facility had created a through-wall defect.

The answer to this challenge was Clock Spring Contour. Because the repair would have to be made on a line carrying hydrocarbons, engineers designed the solution in accordance with ISO 24817, which gives requirements and recommendations for the qualification, design, installation, testing and inspection for externally applied composite repair systems to corroded or damaged pipework, pipelines, tanks and vessels used in the petroleum, petrochemical and natural gas industries.

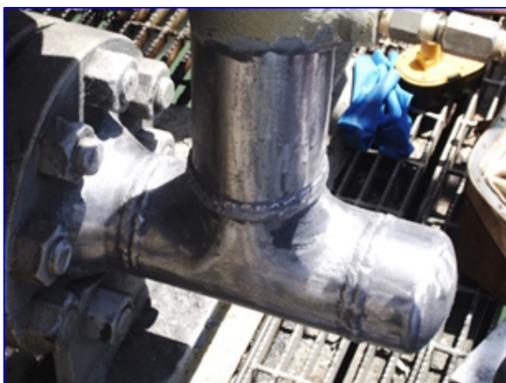
Trained installers cleaned the spool section to create an adequate surface profile equivalent to SA2/NACE#3.

The repair team, made up of local Clock Spring trained and certified technicians, executed the Contour installation on the spool sections. The first step was to clean the spool section using power tools to remove the coating before applying a bristle blaster to create an adequate surface profile equivalent to SA2/NACE#3 so the composite repair could be installed.
