Contour Mends Pinhole Leak on a Topside Weldolet

West Africa

Pipe Details

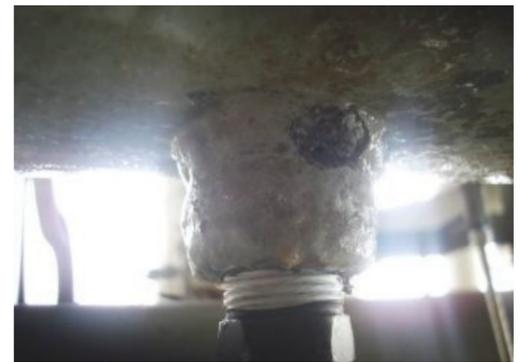
The hole is sealed using a small amount of hand mixed epoxy so LEL levels could be established at 0%

A team of 2 Clock Spring trained and certified installers sealed the pinhole using a small amount of hand mixed epoxy so that LEL (Lower Explosive Limit) levels could be established at 0%. The next step was to clean the area to be repaired to the SSPC.SP11 standard, using power tools on the bare metal, leaving the surface free of all visible oil, grease, dirt, dust, mill scale.

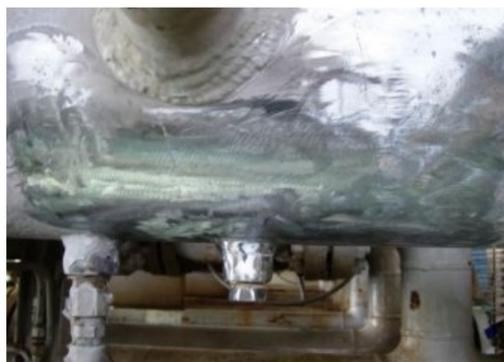
Repair area cleaned to SSPC.SP11 surface preparation standards.

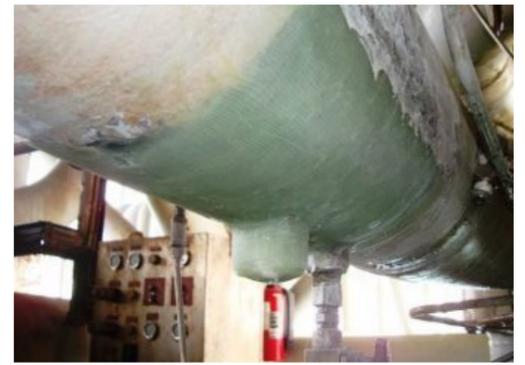
With the resin cured and the repair inspected for defects, the peel ply is removed.

Peel ply was applied over the entire repair during the curing process. When the resin cured, the peel ply was removed, and the repair area was inspected for defects such as de-lamination and dry spots.

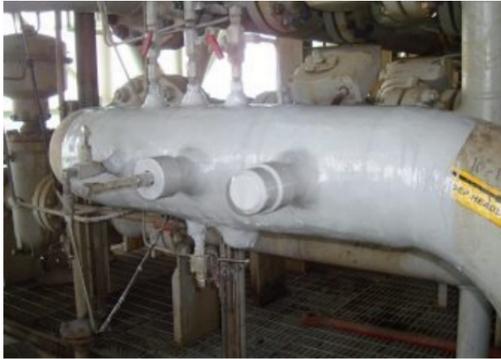
The repair section is coated for UV protection

As in the earlier repair, the peel ply was removed when the resin had cured, and the glass was inspected for defects. When the determination was made that the repair was sound, the entire area was coated for UV protection.
