Contour Reinforces Corroded Cooling Water Line

BENELUX

Summary

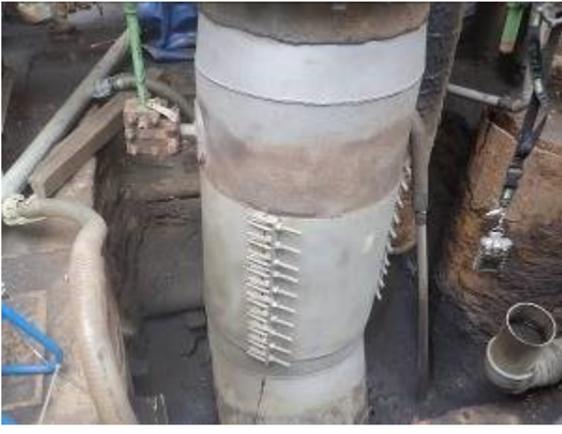
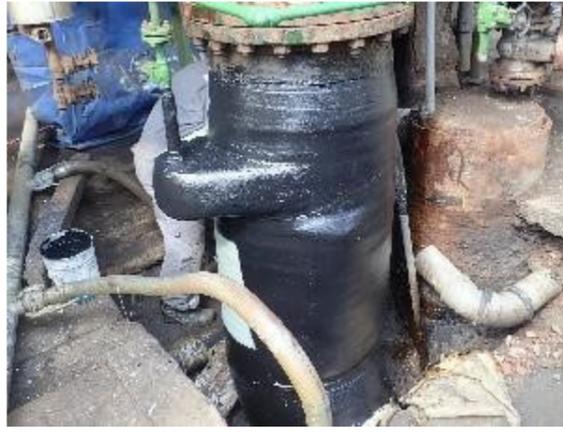
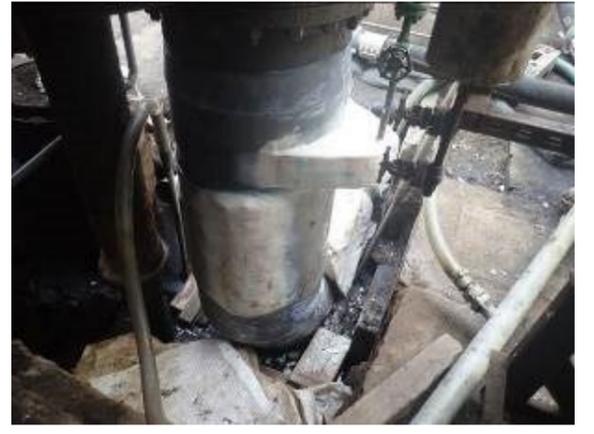
Internal corrosion on a cooling water system led to leaks in the header pipe and a connected nozzle elbow. The nozzle elbow was clamped but created a stress zone in the nozzle pipe connection to the header due to the clamp weight. A temporary repair clamp was installed on the header to mitigate the leak but left the pipe unreinforced and susceptible to failure. To mitigate both degradation modes, the nozzle clamp was transition with load transfer filler to the header and 14 layers of Contour were applied in accordance with design standards. On the downstream straight run of pipe, 9 layers of Contour were installed over the temporary clamp.

Internal corrosion on a DN700 (24-inch) cooling water line in a refinery in Western Europe led to a loss of containment that required attention. The leak was stopped using a temporary leak sealing clamp, and a second leak on a DN 25 (1-inch) elbow from a nozzle off the DN700 pipe was addressed with a traditional leak box. The operator wanted the clamps to be wrapped with Contour to ensure the pipe would remain fit for purpose until the next planned shutdown for the cooling water system.

A composite solution was ideal for this pipeline because the remaining wall thickness was insufficient for a welded repair. The thin pipe wall posed a welding risk because of the danger of accidental burn through and creating a larger leak.

After careful deliberation, the decision was made to repair the lines using Contour, an engineered wet applied repair system, featuring quad-axial stitched fiberglass cloth applied with two-part epoxy and a filler material.

CSNRI trained installers inspected the pipe surface and grit blasted the areas deemed sound for repair. A team of 2 technicians applied load transfer filler material around the clamps to ensure there were no voids under the repair, creating a geometry suitable for application of the composite repair and ensuring the loads from the pipe would be transferred to the composite that provides reinforcement. With the pipe prepared, the technicians applied 9 layers of Contour to the straight pipe and 14 layers at the tee. When the composite was completely cured 8 hours later, the installers painted over the repaired area to provide barrier protection from damage caused at soil-to-air interface locations.

The entire repair was completed in only 2 days, with the cooling water system in normal service.
