# Contour Repairs 4-inch Prover Loop

West Africa

### Summary

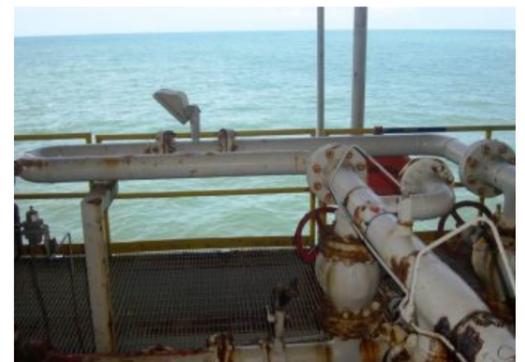
External corrosion resulted in several pinhole leaks on 4-inch (101.6 mm) diameter sections of the prover loop on a metering skid on a platform offshore West Africa.

*The Prover Loop comprises five spool pieces, where corrosion had created multiple pinhole leaks.*

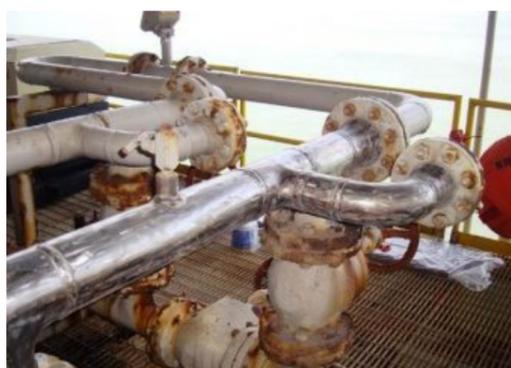
*The repair area is cleaned to SSPC.SP11 surface preparation standards.*

The next step was to clean the area to the SSPC.SP11 standard, making sure the surface was free of all visible oil, grease, dirt, dust, mill scale. The paint was removed, and the pipe surface was 'keyed' to give sufficient bonding between composite (fiber glass) and substrate (steel pipe).

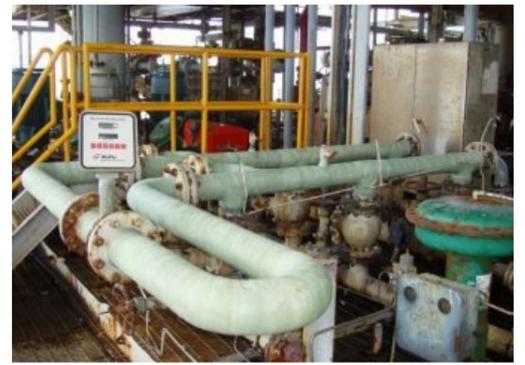
*When the composite repair was cured, the peel ply was removed and the repair inspected for de-lamination, dry spots, and disbonding before the line was coated for UV protection and returned to service.*

When the composite was fully cured, the peel ply was removed and the repair inspected for de-lamination, dry spots, and disbonding. With all of the pinholes addressed, the prover loop was coated for UV protection and returned to service in only 4 days.
