Contour Repairs Internal Corrosion on Heat Exchanger

Australia

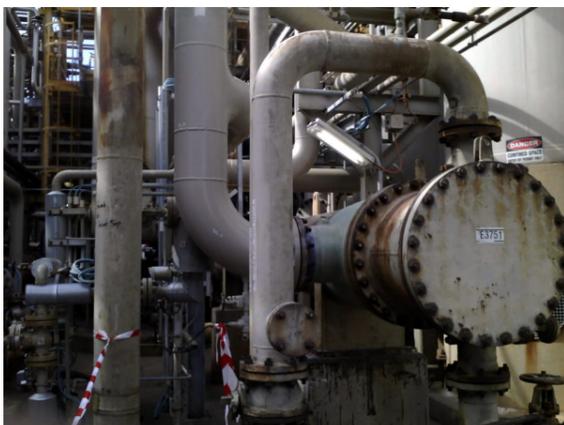
A routine inspection at an Australian refinery uncovered an area of metal loss in a 600-mm (24-inch) heat exchanger that needed prompt attention. Allowing the problem to remain unaddressed could have caused a reliability issue within the refinery, so the owners began looking for a suitable way to repair the line.

High pressure and temperature were top of mind when a refinery owner began looking for a way to repair a corroded heat exchanger.

Experts in the Clock Spring UK office evaluated the damage and designed a 46.2 mm (1.8 inch) thick Clock Spring Contour repair to ISO 24817 2015 guidelines using Clock Spring Contour QUAD glass with CS700 epoxy resin. When completed, this repair would meet the exacting environment and safely contain pressure from a leaking hole up to 50 mm by 50 mm (2 inch by 2 inch) for a 2-year service life.

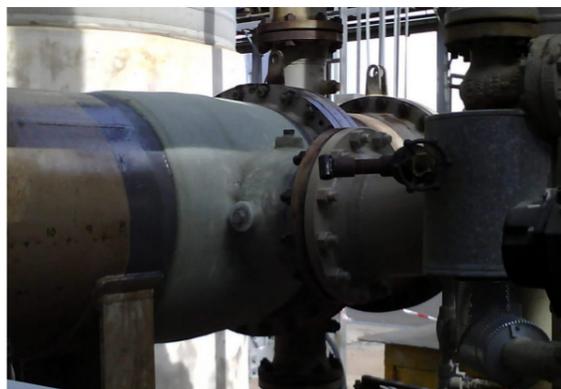
The complex geometry of the heat exchanger was no problem for Clock Spring Contour. The completed composite repair enables 2 more years of safe service.

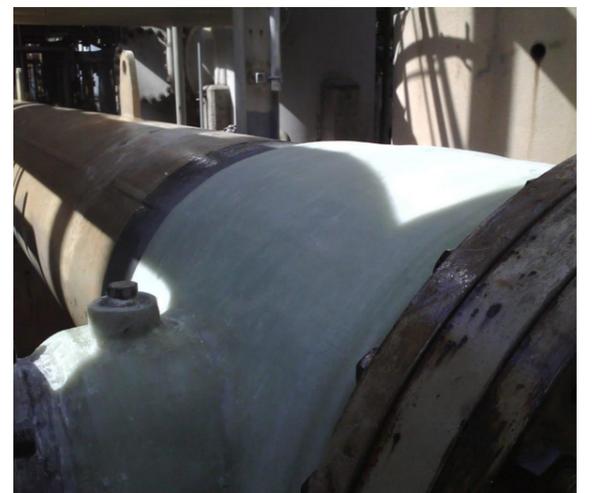
The Clock Spring Contour repair was completed in 5 days without having to shut in the line.

A team of two Clock Spring trained technicians used a bristle blaster and solvent to prepare the area for the Contour repair and installed all the layers, effecting a complete solution in only 5 days without having to shut in the exchanger and allowing the refinery to continue normal operations.
