Contour Repairs Leaks in a Cooling Water Line

Benelux

Pipe Details

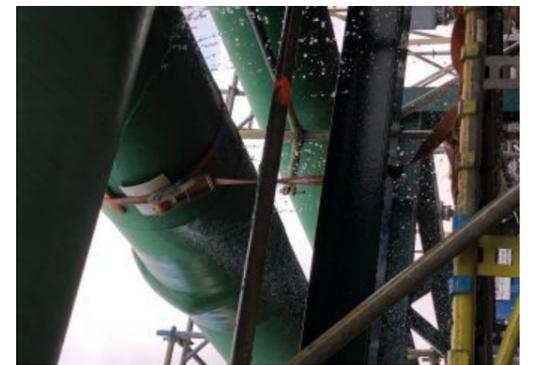
- 610-mm (24-inch) cooling water pipe developed a leak as a result to internal corrosion
- 5 Bar (72.5 psi) Design Pressure
- 65°C (149°F) Design Temperature

Workers at a Benelux refinery discovered a leak in a 610-mm (24-inch) cooling water pipe.

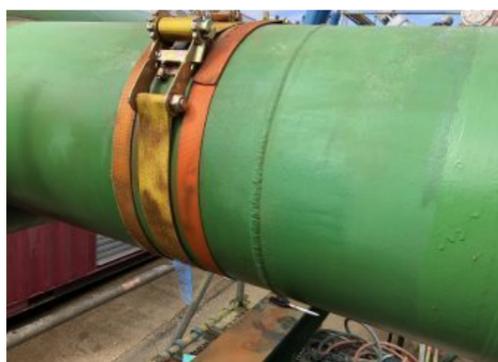
Installers began preparing the line for repair around an area where a metal plate and ratchet straps held an O-ring in compression over the leak.

While refinery operations continued as usual, installers began preparing the line for repair around an area where a metal plate and ratchet straps held an O-ring in compression over the leak. With the pipe area ready for the installation, the team applied an eight-layer Clock Spring Contour repair.

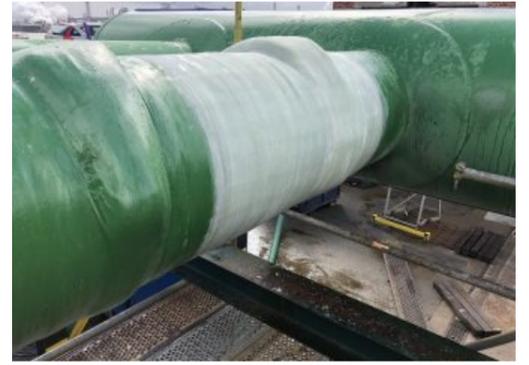
A team of 3 technicians completed the Contour repair in 2 days, delivering a solution with a defined life of 10 years for about half the cost of an alternative repair.

Following standard installation procedures, 3 technicians executed the complete repair in 2 days without disrupting operations, delivering a repair with a defined life of 10 years for about half the cost of an alternative solution.
